Flood and Erosion Control Board Meeting  
September 11, 2023  
Board of Education Auditorium, 129 Church Street  
6:00 P.M.  
Join Zoom Meeting

A. DPW Flooding Memo

On July 16, 2023 The City of Bristol experienced a high intensity rain storm within a relatively short period of time (approximately 5.2 inches of rain in less than 2 hrs). The storm caused localized flooding and property damage throughout the City. This report is a summary of the current flooding and drainage issues that have been brought to the attention of the Public Works Department.

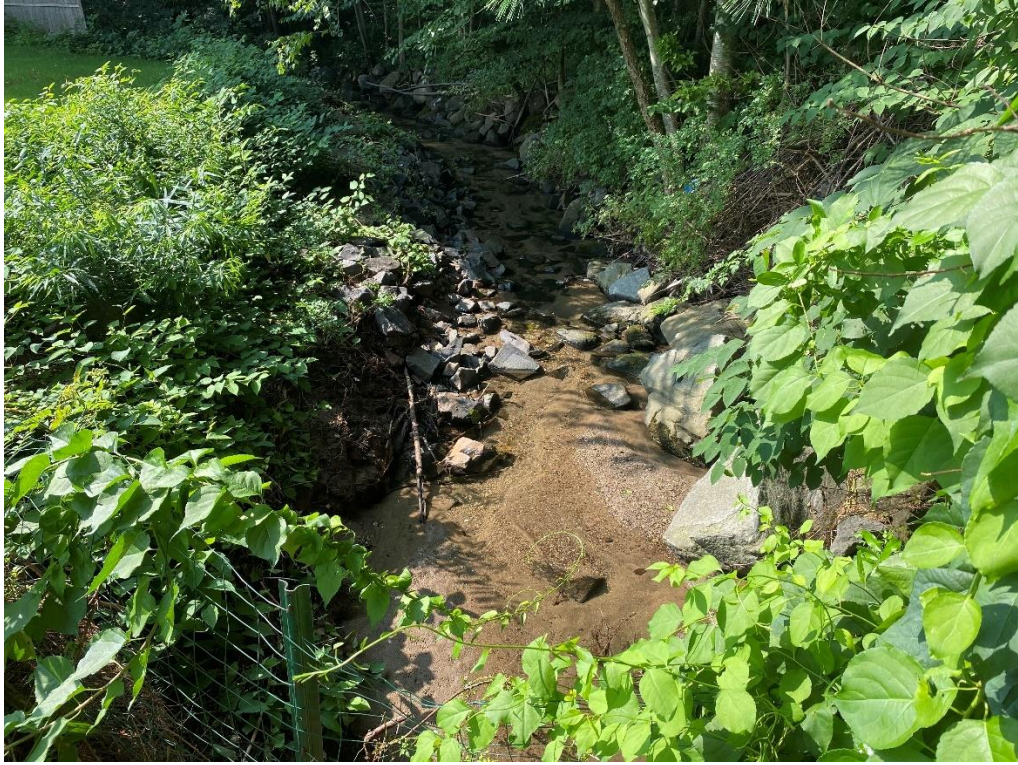
High water levels and erosion of banks along Birge Pond Brook. Resident indicated that riprap along channel has washed away. While onsite the resident claimed that the slopes along the channel are hazardous and that something should be done.

The DPW investigated the claim and noted the following: An unnamed stream runs north to south along west side of 109 Marlene Street. Flows are facilitated under Marlene Street through an existing 72-inch CMP culvert. Each end of the culvert is embedded within a concrete headwall complete with flared wingwalls. The channel and culvert were both found to be located within a City owned easement. Due to thick overgrowth the Department was unable to determine the overall stability of the channel banks. The resident claims the channel armoring around the outlet had eroded away in years past.

*Figure 3: Birge Pond Brook - Looking Downstream*

The DPW crews are scheduled to clear overgrowth from the channel and perform a visual inspection of the existing channel slopes. Based on field conditions of the overall stability of the slopes DPW will install riprap and or regrade existing material to mitigate erosion (if any).

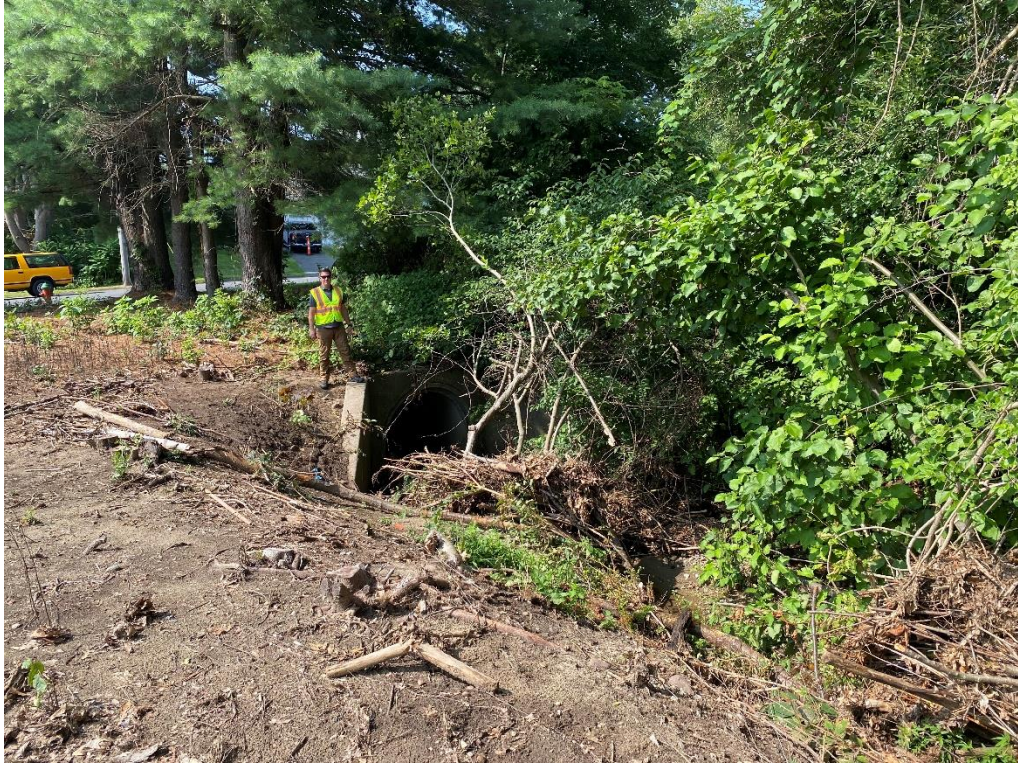
The DPW investigated the claim and noted the following: An unnamed stream runs north to south along west side of 96 Marlene Street. Flows are facilitated under Marlene Street though an existing 72-inch CMP culvert. Each end of the culvert is embedded within a concrete headwall complete with flared wingwalls. The channel and culvert were both found to be located within a City owned easement. During field investigation a large buildup of debris was found within the channel obstructing flows at the upstream end of the culvert. The inside of the culvert was also inspected and it appeared to be clear. While onsite the homeowner explained that due to the buildup of material headwater from the stream overtopped the channel banks and caused flooding around the property.

*Figure 5: Birge Pond Brook - Looking Downstream*

DPW crews cleared debris from the channel. The Department will continue to monitor the situation for any additional flooding.

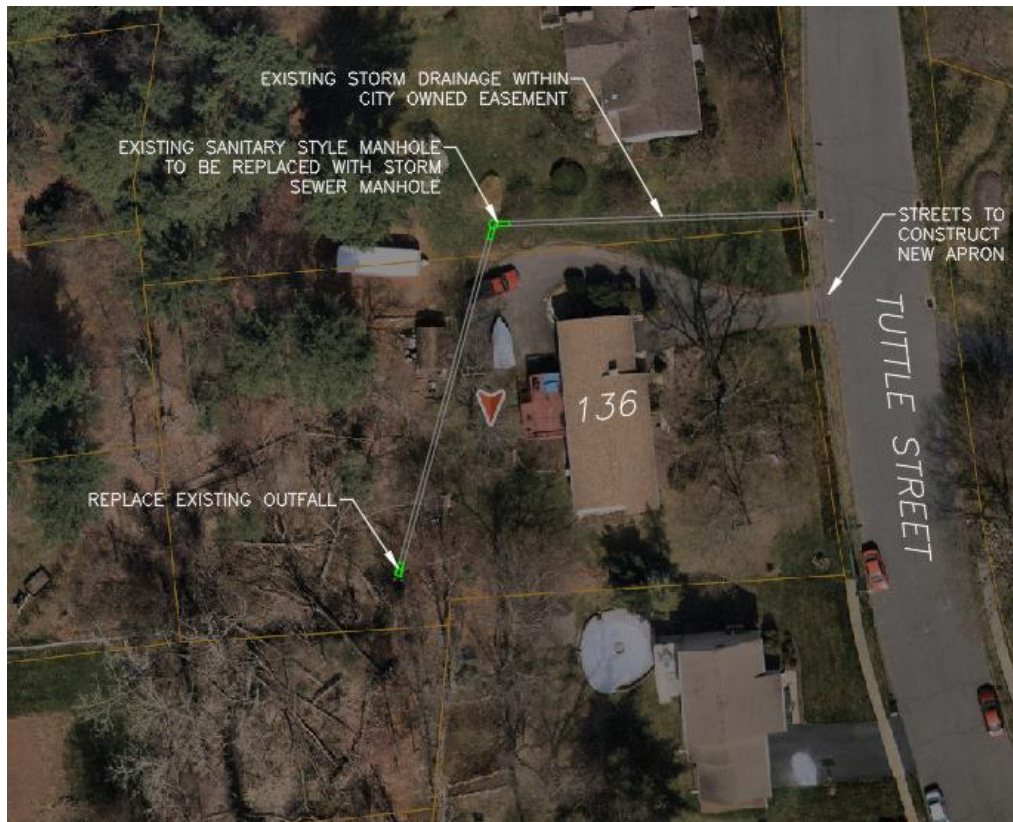
The DPW investigated the claim and noted the following: The existing storm drain adjacent to the driveway of 136 Dino Road currently outlets to an unnamed stream located along the southern property line. The outfall was determined to be located entirely within a City owned easement. A manhole located within the easement was inspected and determined to be a sanitary style manhole with significant scouring along the troughs. In addition, a section of pipe at the outlet has become disconnected and is impeding flows. The property owner informed the Department that stormwater on the street backs up into the roadway and flows down the driveway into the yard. Upon inspection, the lip of the existing driveway apron appears to be less than standard height.

*Figure 7: Proposed Drainage Improvements*

The DPW is scheduled to reconstruct the driveway apron in front of 136 Dino Road. The new apron will be constructed with a standard sized lip to help prevent stormwater from the street from overtopping the driveway. In addition, the Department will replace the existing sanitary style manhole and outfall pipe as shown in the figure below. The existing manhole will be replaced with a standard curbless catch basin to help collect flows within the yard and the outfall will be replaced with a standard flared end section.

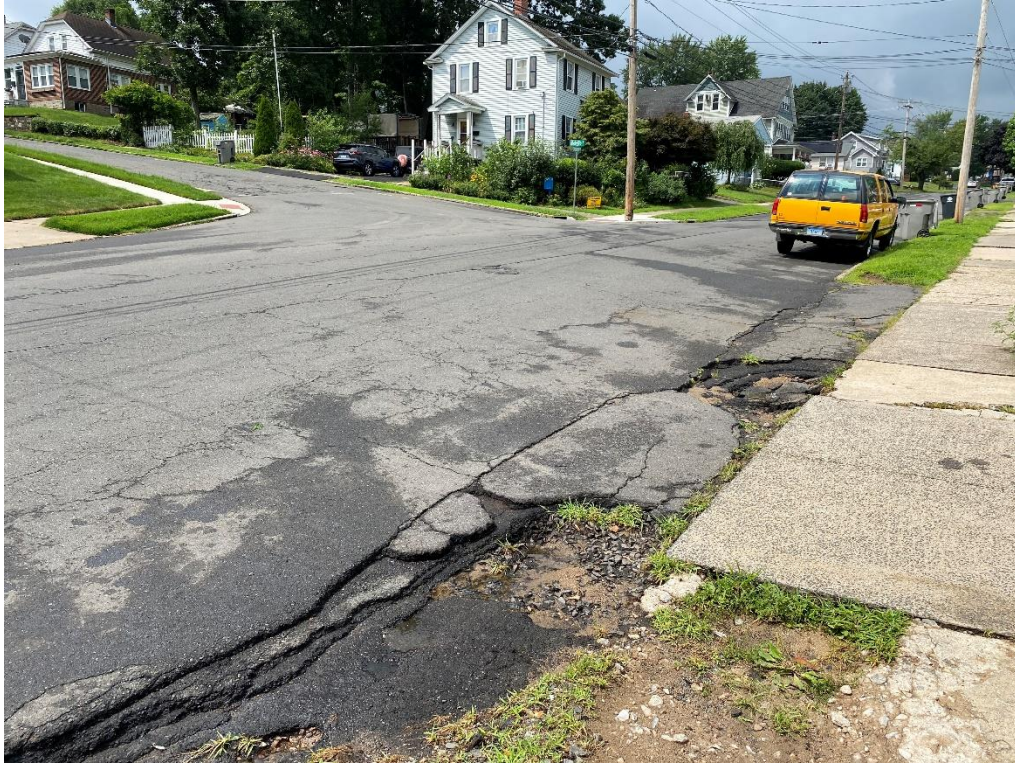
The DPW has investigated the existing site conditions and claimed property damage. From visual inspection the Department believes stormwater from Melville Street and South Street Ext. is overtopping the sidewalk and flowing down the driveway at 72 South Street Extension.

*Figure 12: Driveway Apron Looking Toward Melville Street*

The DPW is preparing a workorder with a private contractor to reconstruct the existing driveway apron, sidewalk, and curbing as shown in *figure 13*. The homeowner has filed a claim for the property damage.

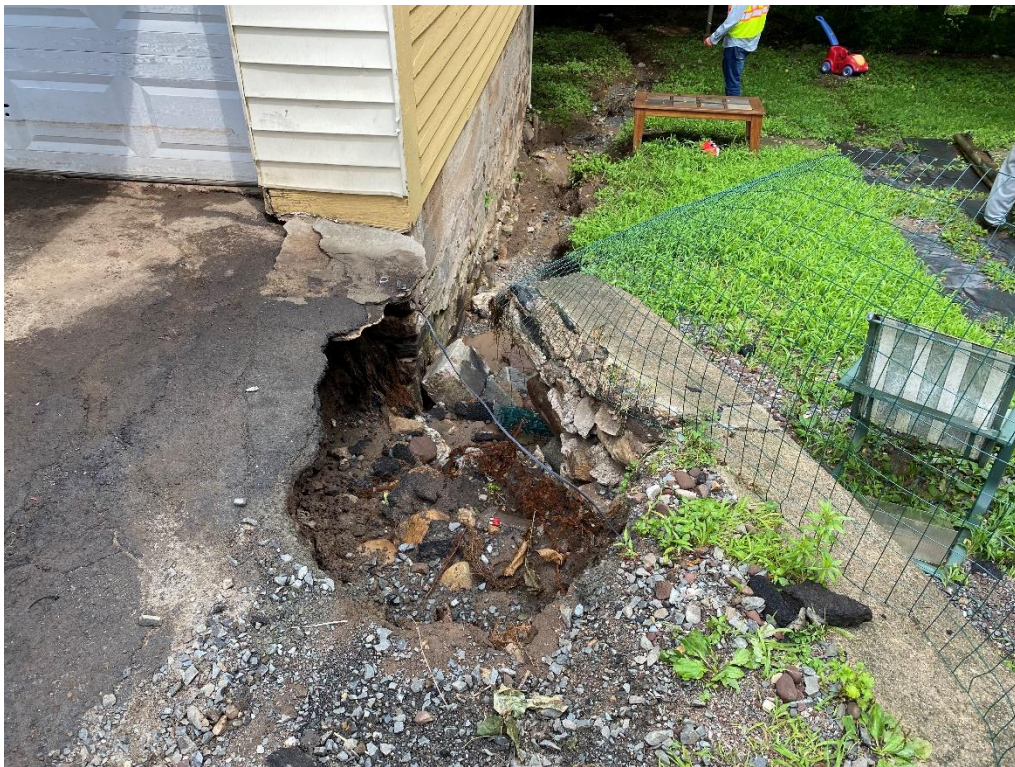
The homeowner of 72 South Street Ext. stated that insufficient drainage along the street has caused damage to the existing sidewalk, driveway, and retaining wall.

*Figure 13: Erosion Behind Existing Retaining Wall*

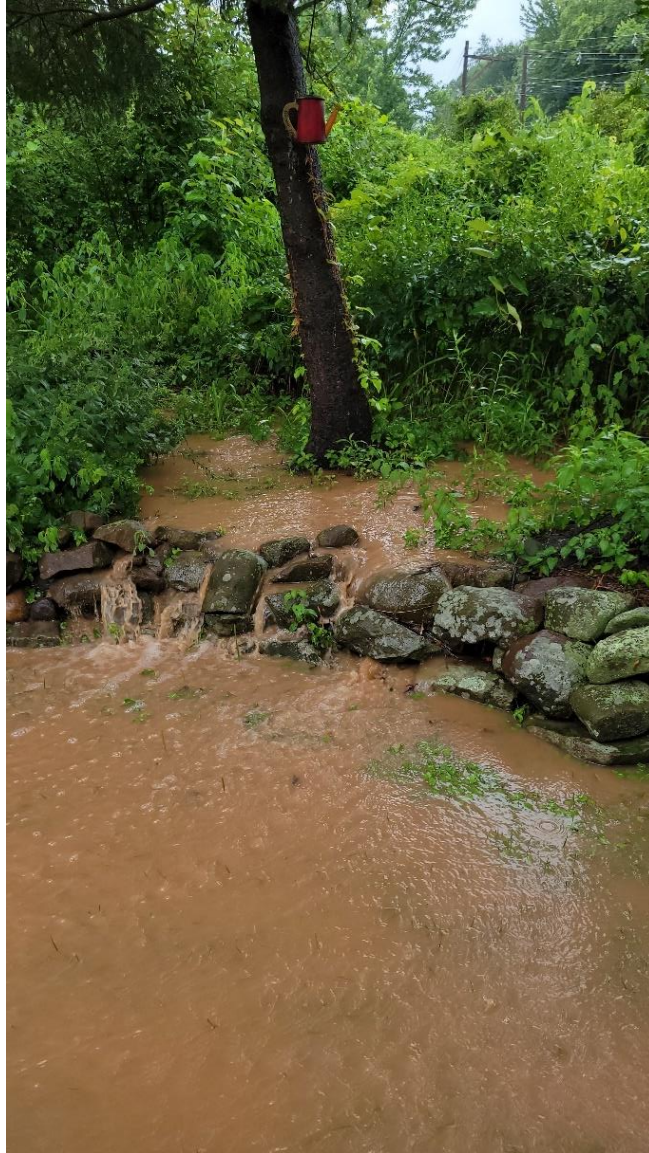
The homeowner of 465 Redstone Hill believes that an adjacent construction site has caused increased amounts of stormwater runoff to flow through her property.

*Figure 15: Stormwater Runoff*

The contractor working at the adjacent construction site has installed additional sedimentation and erosion control measures including a new drainage swale along the back side of 465 Redstone Hill. The existing swale was upgraded from a 2-foot-wide channel to a 6-foot-wide grass lined channel. The property owner has been notified and has informed the Department the swale seems to be operating as intended.

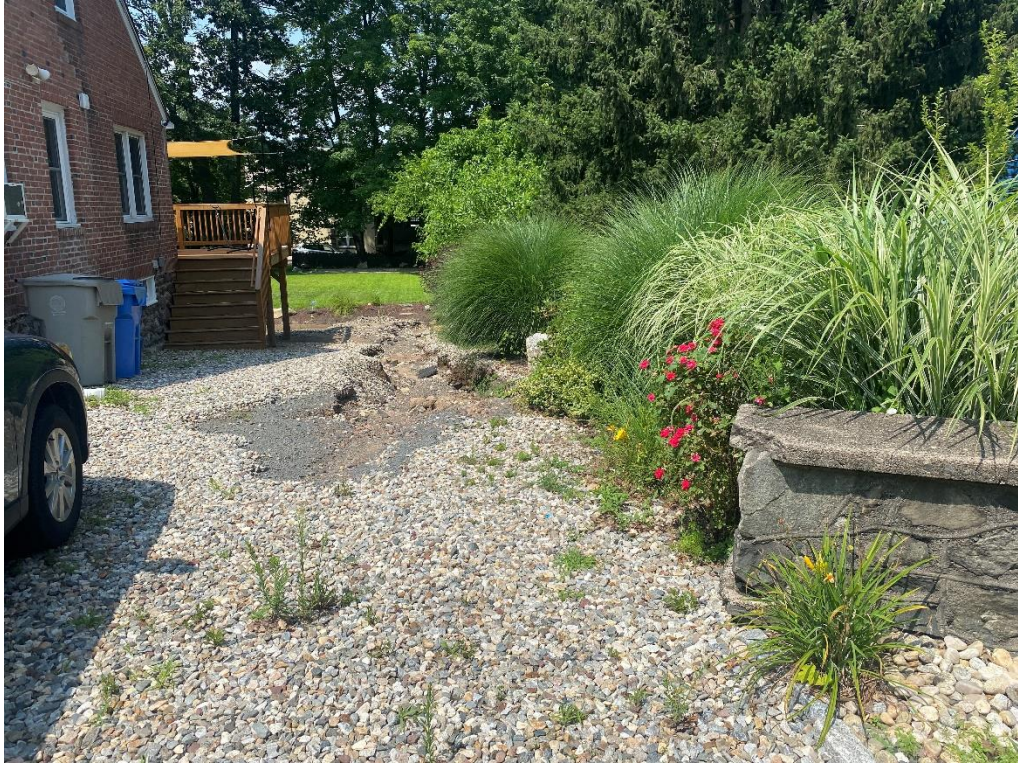
Recent storms have caused erosion of an existing crushed stone driveway. The homeowner of 90 Field Street believes that the culvert adjacent to his property is undersized and has caused floodwaters to overtop the roadway.

*Figure 17: Erosion of Unpaved Driveway*

The homeowner was made aware that The City is in the process of securing funds to have the culvert adjacent to his property replaced and that construction is anticipated to begin in 2025. The proposed structure is an 11 ft x 4.5 ft precast concrete box culvert with flared concrete wingwalls. In addition, to replacing the existing culvert this project will involve realignment of the existing channel. The new channel alignment will improve the hydraulic conductivity and reduce the likelihood of water overtopping the roadway. For construction of the new culvert, temporary and permanent easements will be required for excavation but have not yet been granted by the property owners. Temporary reconstruction of the driveway and shoring of the existing wall is being considered as part of the negotiation for these easements.

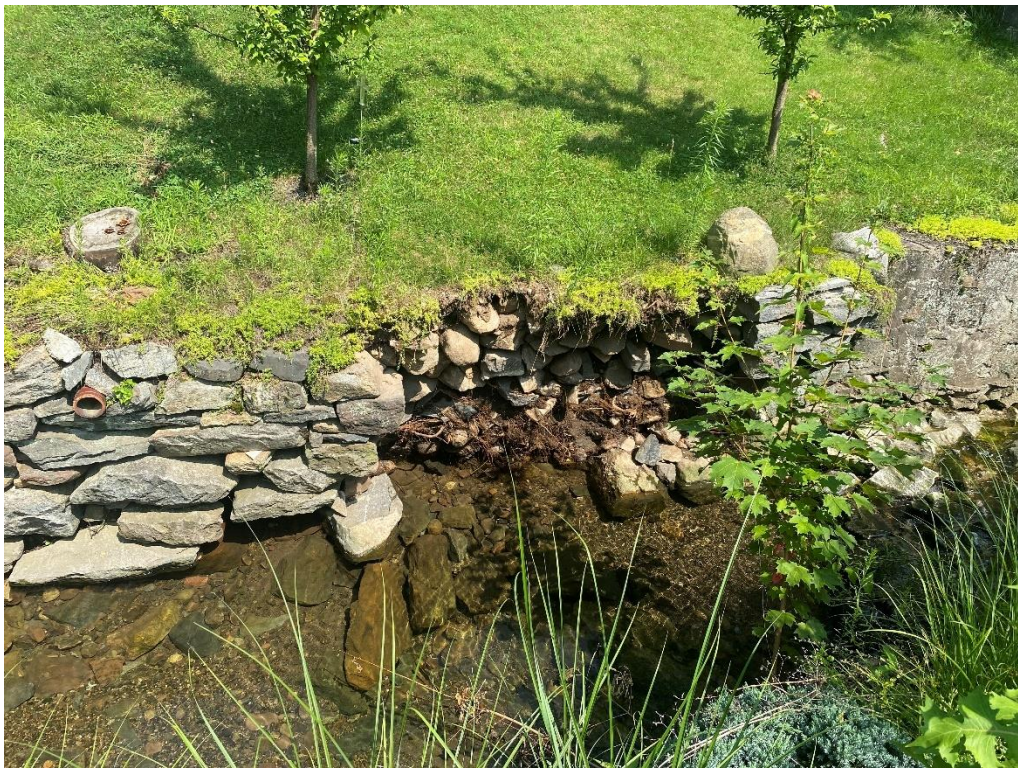
*Figure 18: Channel Wall Adjacent to 90 Field Street*

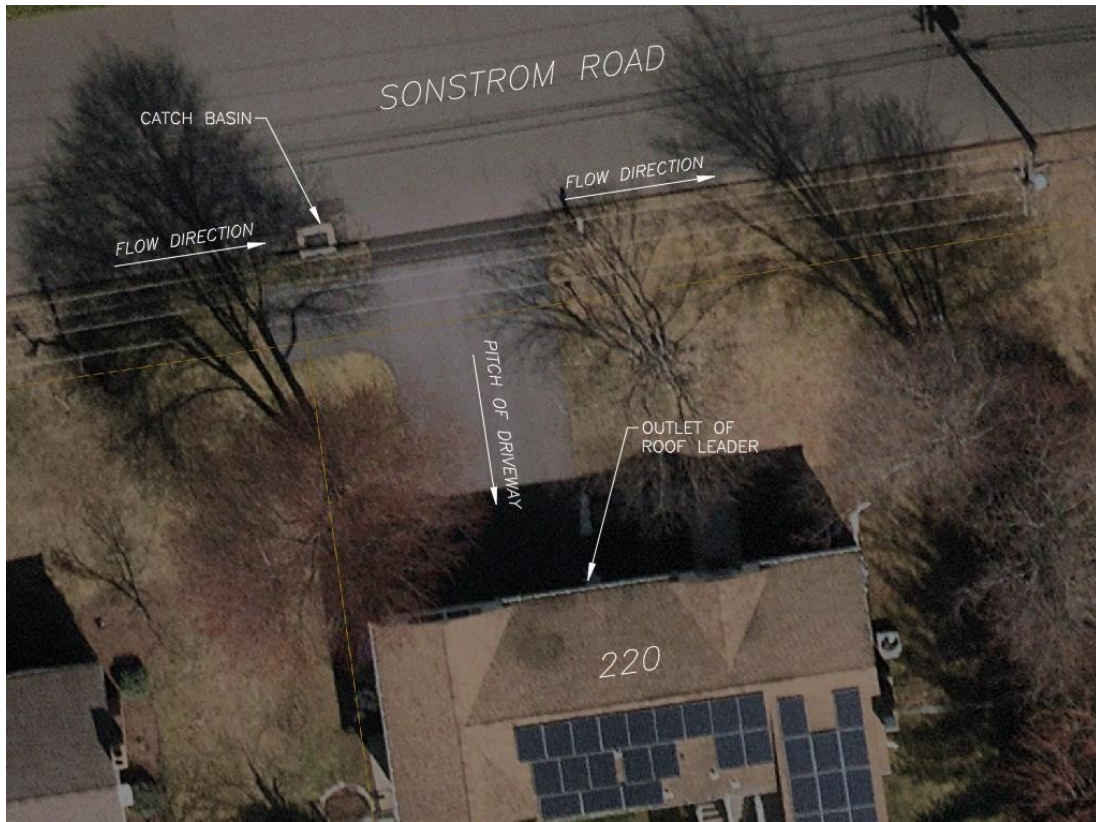
*Figure 23: Site Conditions at 220 Sonstrom Road*

A City catch basin is currently located on the high side of the driveway. No additional City action is proposed.

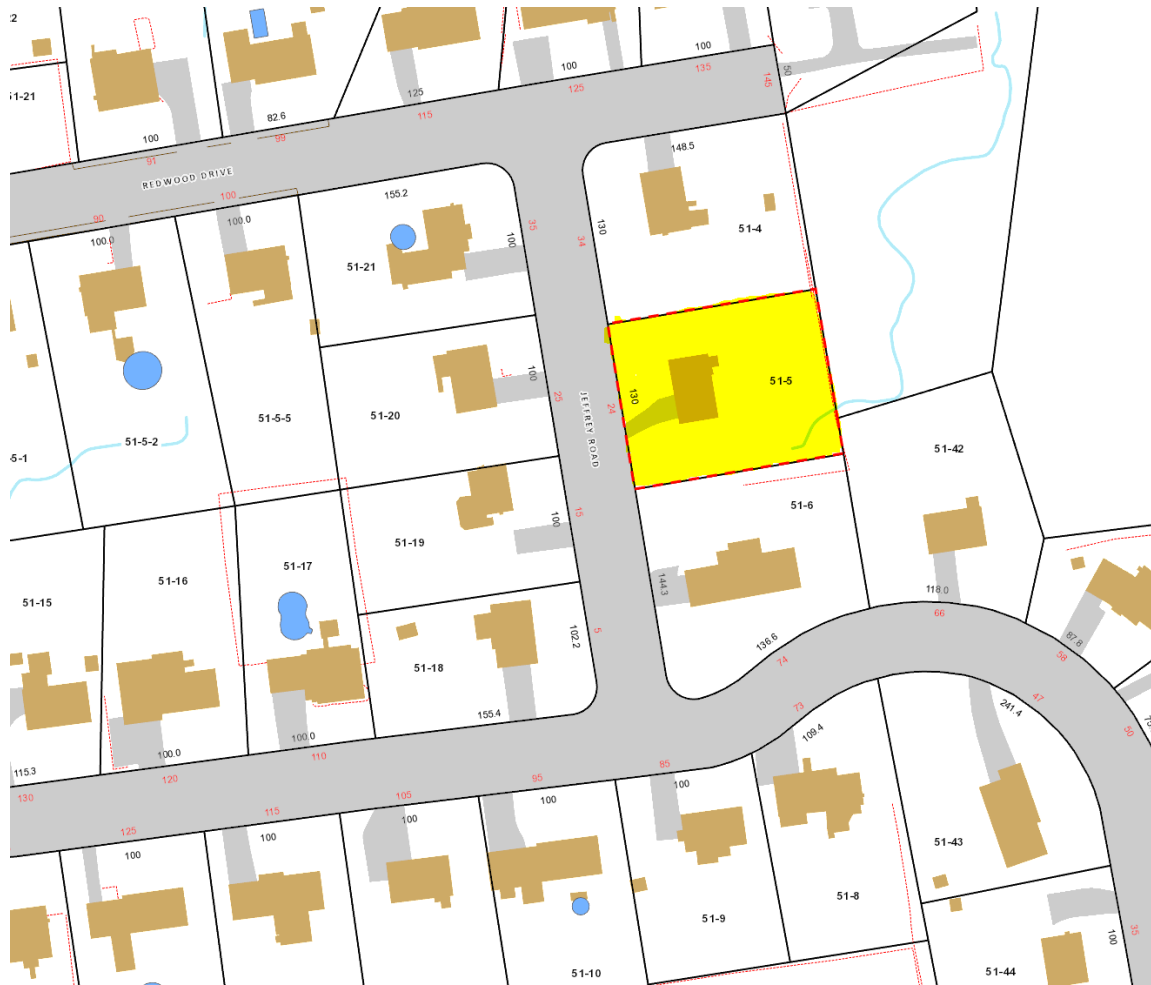
Figure 25: Flooding at 24 Jeffrey Road

The DPW cleaned/cleared the basins and jetted the storm drainage lines along Jeffrey Road. In addition, the Department is currently drafting conceptual plans to improve flows from the unnamed stream. The current plan would be to remove the existing basin, several sections of pipe and realigning the channel so it flows more naturally into the storm drain.

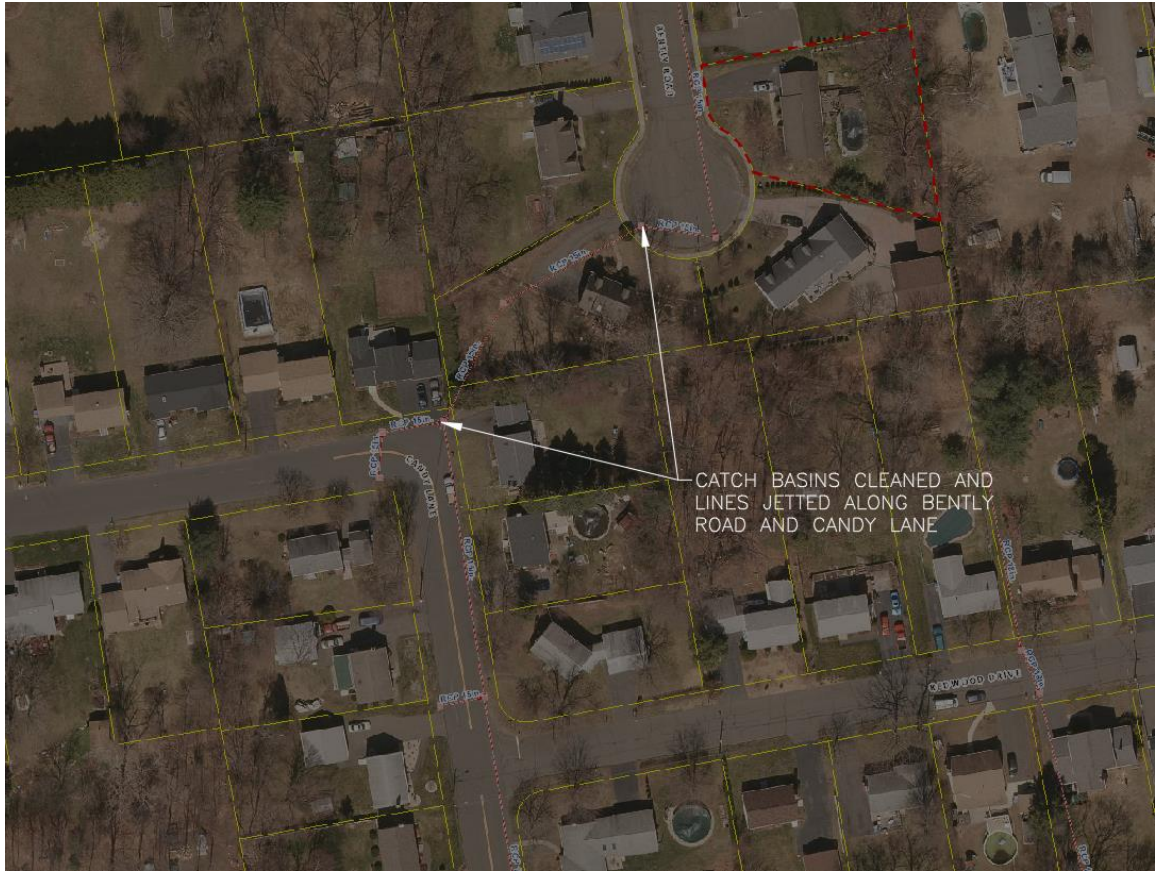
DPW inspected the storm sewer from Bently Road to Candy Lane but only observed a minor buildup of sediment within the existing catch basins.

*Figure 30: Maintenance of Bently Road Drainage System*

The DPW cleaned/cleared the catch basins and jetted the storm drainage lines. The department will continue to monitor this system during future storm events.

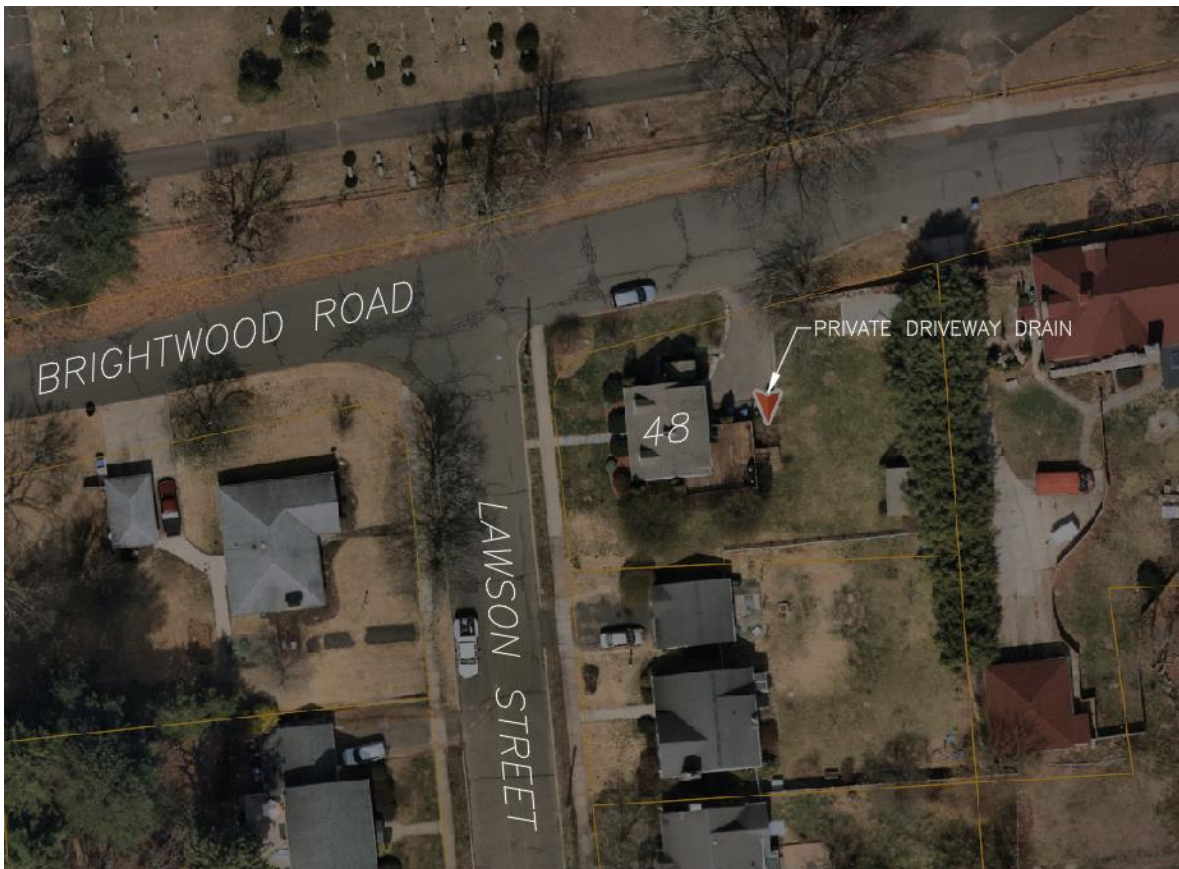
Homeowner believes a clogged catch basin has caused her driveway to flood.

Figure 31: Existing Conditions

The homeowner has been notified that the City will take no action as this is a private issue.

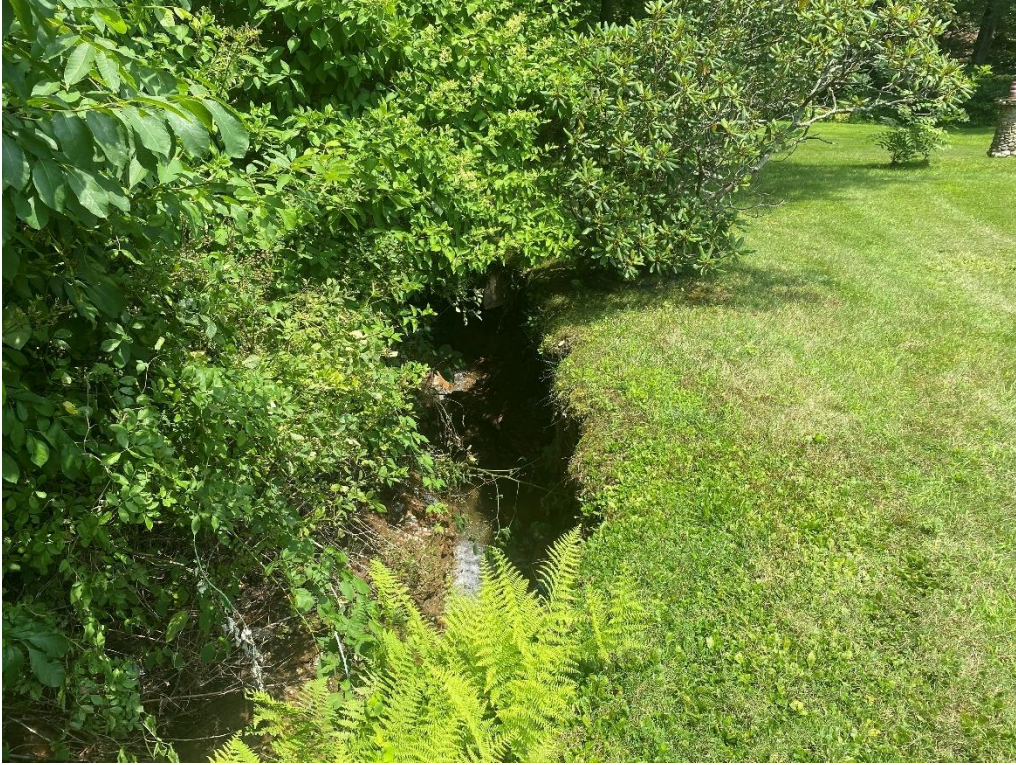
The resident believes that due to increased runoff from past roadway improvements projects, the stream on his property has significantly eroded and has become a hazard.

*Figure 33: Erosion at Invert of Channel*

The DPW is currently in the process of producing concept plans to stabilize and armor the outfall within The City's right-of-way. Stabilization will involve cutting back slopes and installing riprap along the channel banks. In addition, a detention pond located upstream will be investigated to ensure it is functioning as designed.

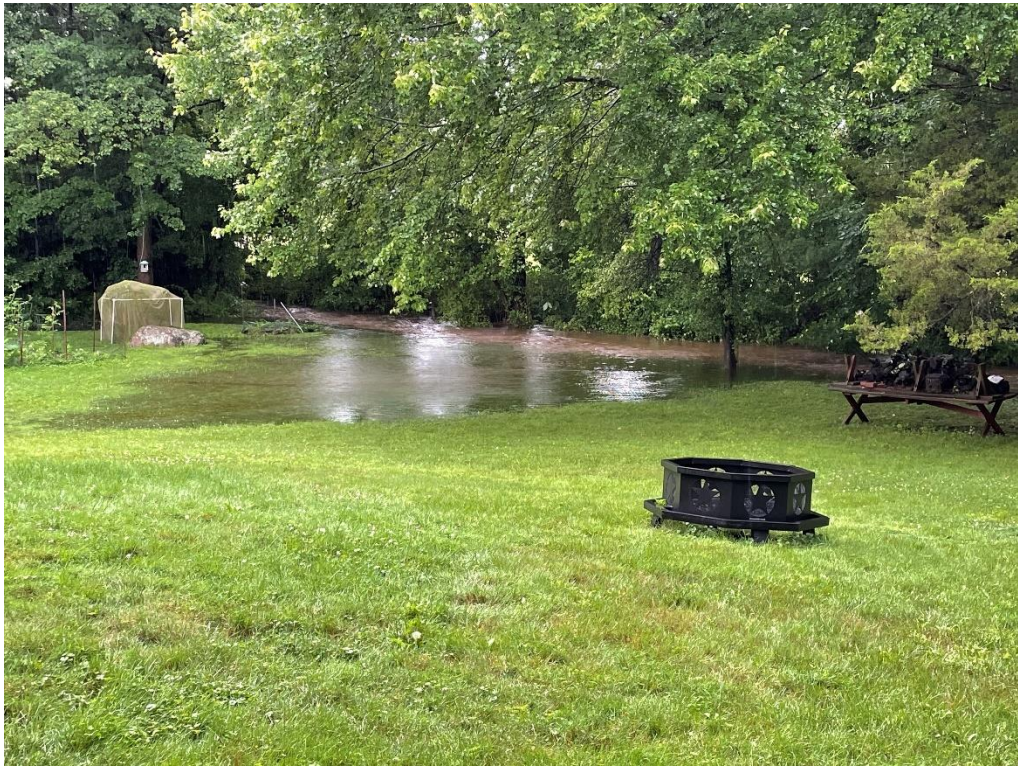
Resident indicated that the stream on his property has been eroded by the recent storm and has caused flooding in his yard. The resident also believes that the City has an easement for maintenance of the stream.

A 24" storm water outfall pipe located along the north side of 302 Candlewood Drive discharges to an unnamed stream along the east side of the property. The outfall pipe is located within a City owned easement and the stream itself appears to be entirely on private property. During field investigation the DPW noted that erosion within the channel appears to be minor. Small deposits of sediment were observed along the channel banks.

*Figure 35: Stormwater Overtopping Channel Banks*

The DPW is in the process of producing concept plans to stabilize the outfall within the City's easement. The proposed work will likely involve removing sediment and installing riprap at the drainage outfall. The City will take no action in maintaining areas of the channel located on private property.

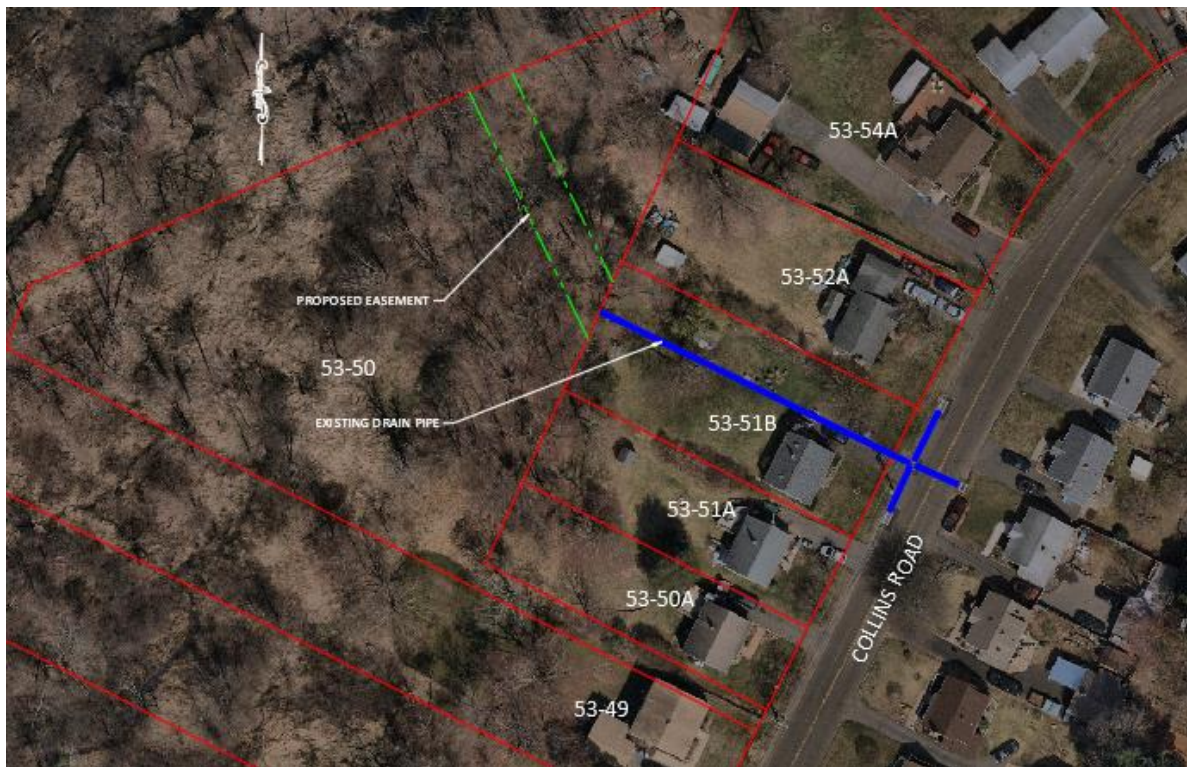
Figure 37: Location of Proposed Easement

The DPW has contacted the owner of 87 Collins Road and the adjacent property owner informing them that the City is requesting an easement for drainage improvements.

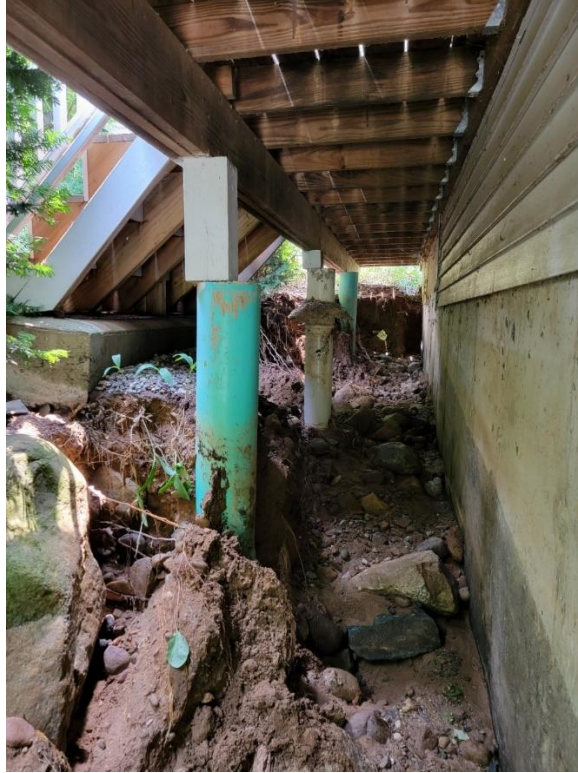
Stormwater from the street has been jumping the curb and driveway apron and has caused erosion around the foundation of the house.

The DPW inspected the existing storm system and when doing so observed evidence of stormwater flowing from the street onto private property toward 74 Peck Lane. The department believes this problem is largely contributed by not having any catch basins along the west gutter line for a 1,300' stretch uphill of the property. It is likely that storm water is channelizing along the gutter and overtopping the curb in front of 74 Peck Lane.

*Figure 40: Erosion of Material Caused by Stormwater*

The DPW is currently in the process of developing a conceptual plan aimed to reduce the amount of stormwater that contributes to the flooding at 74 Peck Lane. Improvements will include installing a new catch basin(s) on the uphill side of the driveway, constructing a more substantial curb, and reconstructing the driveway apron with a standard sized lip.

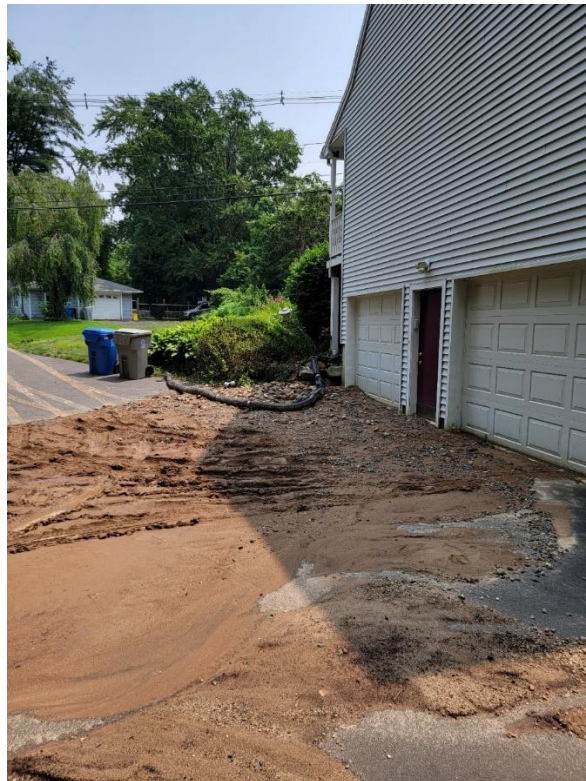
*Figure 41: Deposits of Eroded Material*

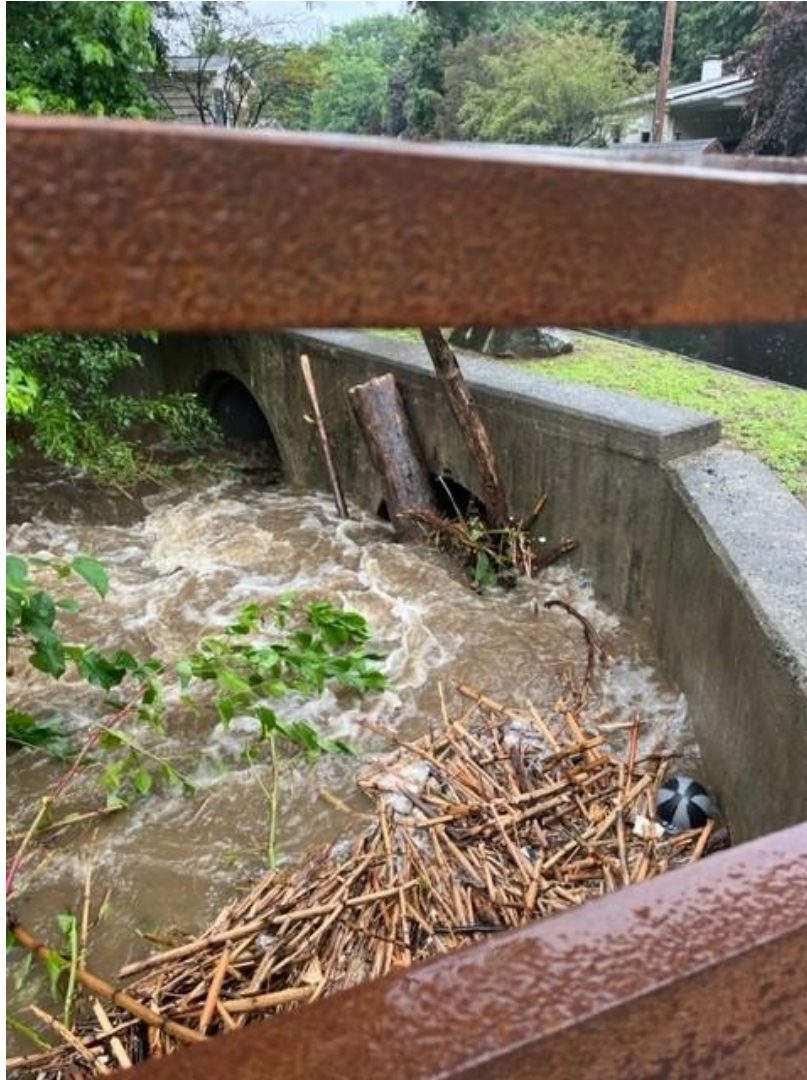
*Figure 44: Debris Blocking Flows at Culvert*

A private contractor performed a visual inspection of the culvert and removed debris including a large obstruction at the outfall shown in the figure below.

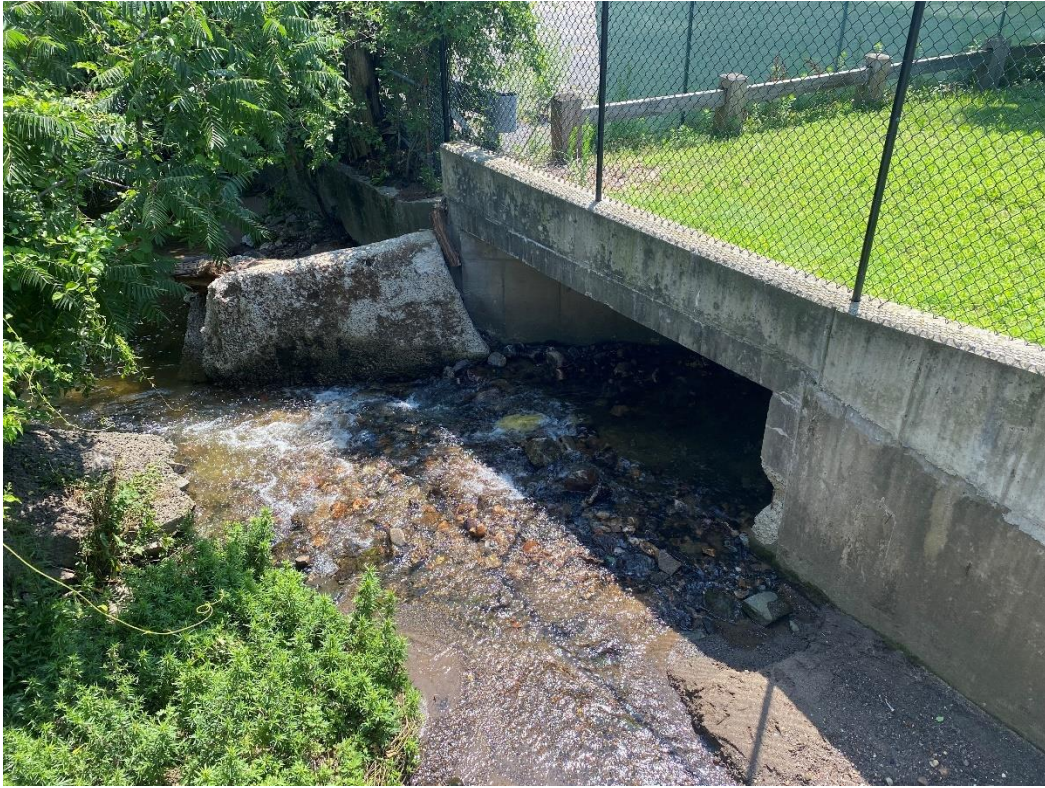
*Figure 45: Obstruction at Culvert Outfall*

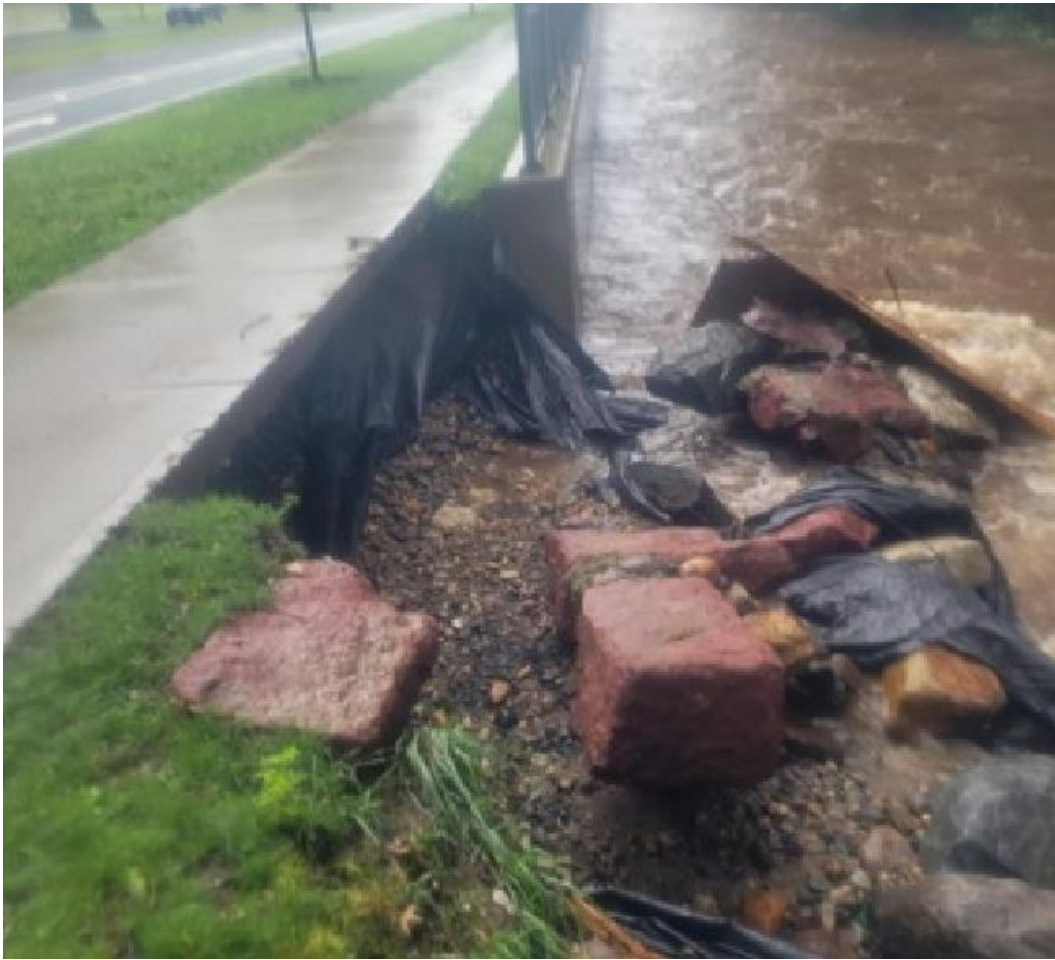
*Figure 47: Collapse of Existing Dry Stack Stone Wall*

A private contractor was contacted and will be submitting a quote to make repairs.

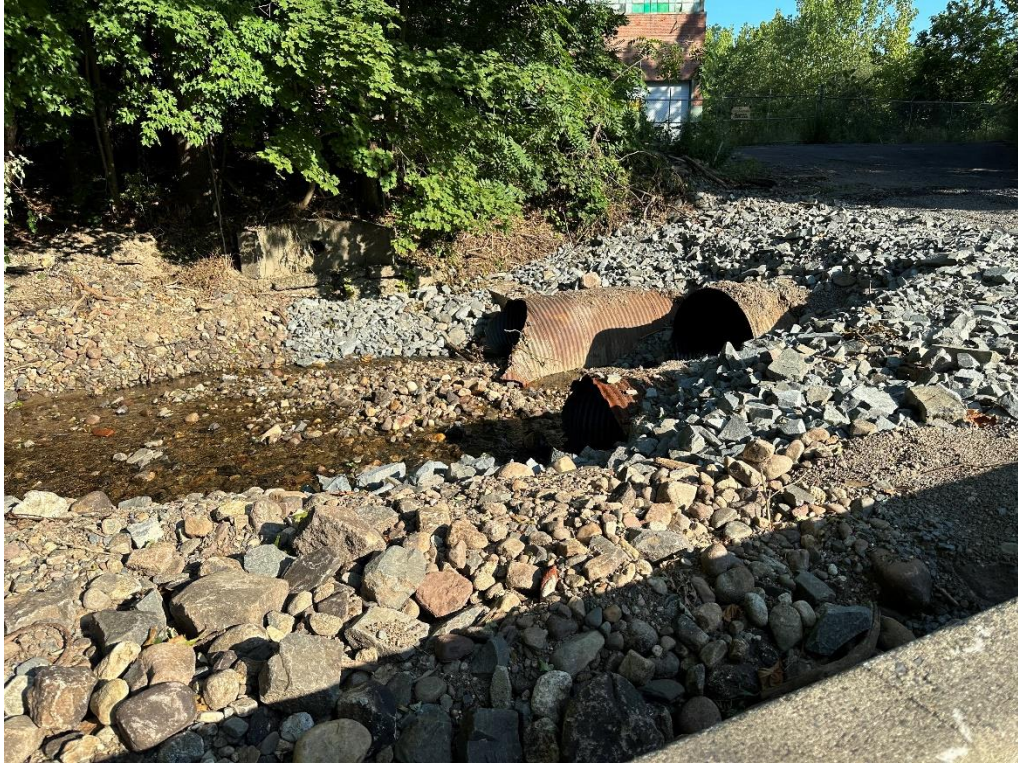
*Figure 49: James Street Culvert*

The existing culvert is currently owned and maintained by Laviero Contractors. Following the recent storms, Laviero was onsite to clear the culvert from brush and debris. The DPW also sent a crew to clean the existing basins and to sweep the street.

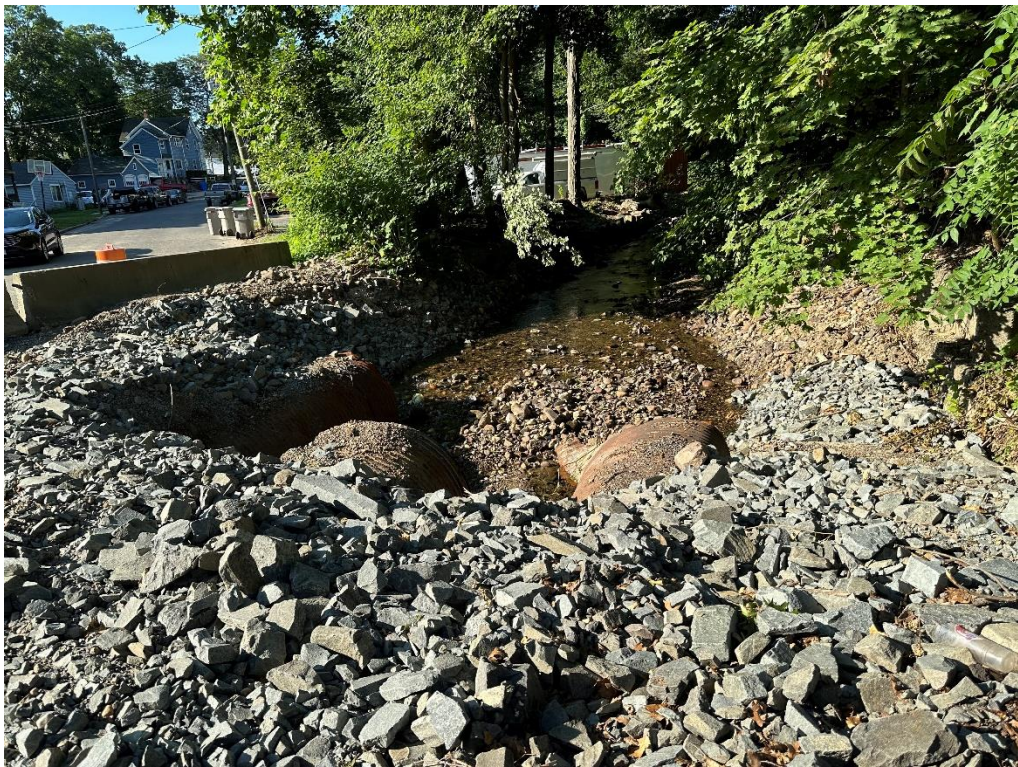
*Figure 50: Channel Looking Downstream*

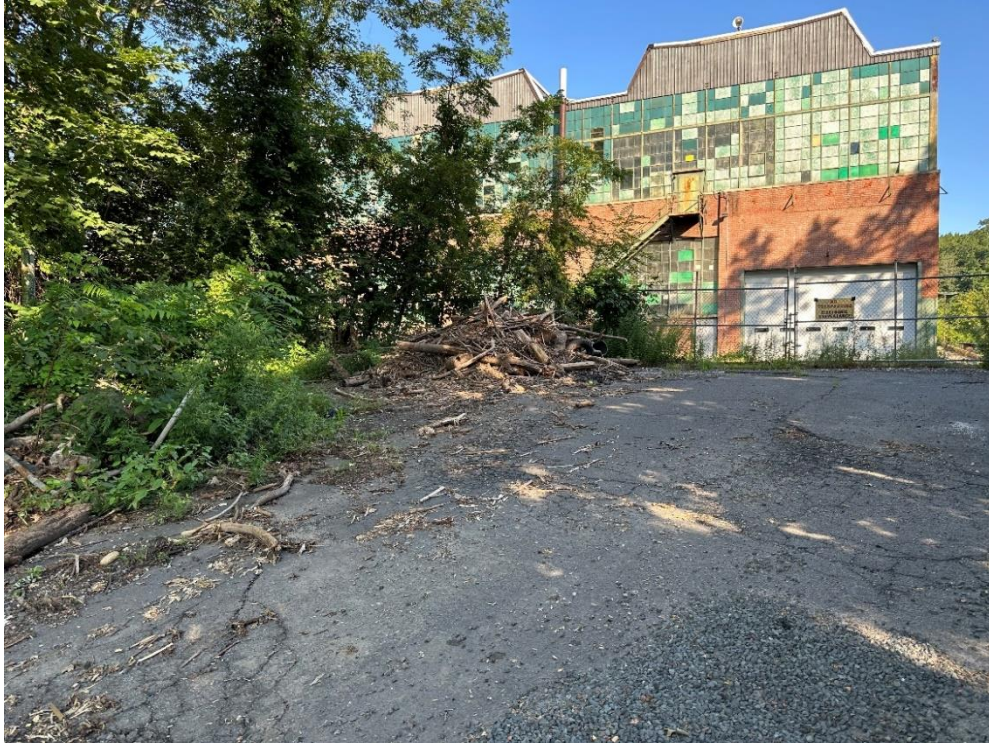
*Figure 51: Debris Removed from Channel*

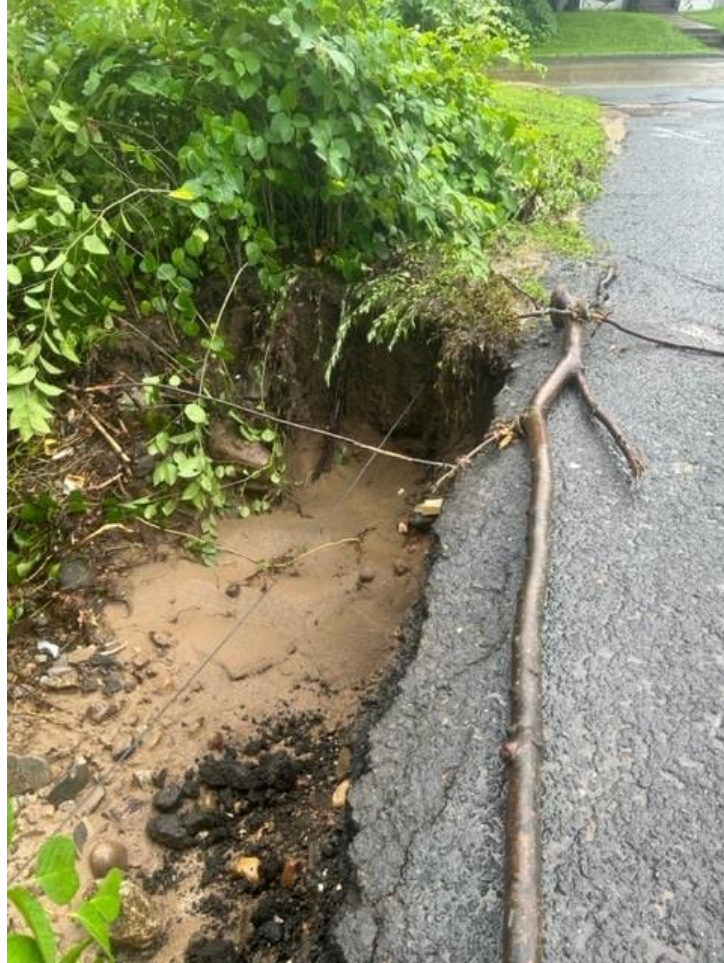
An unnamed stream flowing south to north crosses Divinity Street 250 ft east of the intersection of Peck Lane. Flows are facilitated by a 5 ft x 5 ft concrete box culvert which is hydraulically undersized. During the storm on July 16<sup>th</sup> floodwaters overtopped the culvert and caused significant damage do the adjacent properties as shown in the photos below.

*Figure 54: Damaged Driveway on Private Property*

The DPW sent a crew onsite to temporarily repair the damages to the adjacent properties. The Department is currently in the process of finalizing the design of a new culvert. The culvert size will increase from 5 ft high X 5 ft wide to 5 ft high by 8 ft wide. Work is scheduled to be completed after the completion of the CT DOT Route72/69 project. Culvert is currently on the West End intersection detour plan (2024).
