Flood and Erosion Control Board Meeting  
September 11, 2023  
Board of Education Auditorium, 129 Church Street  
6:00 P.M.  
Join Zoom Meeting

A. DPW Flooding Memo

On July 16, 2023 The City of Bristol experienced a high intensity rain storm within a relatively short period of time (approximately 5.2 inches of rain in less than 2 hrs). The storm caused localized flooding and property damage throughout the City. This report is a summary of the current flooding and drainage issues that have been brought to the attention of the Public Works Department.

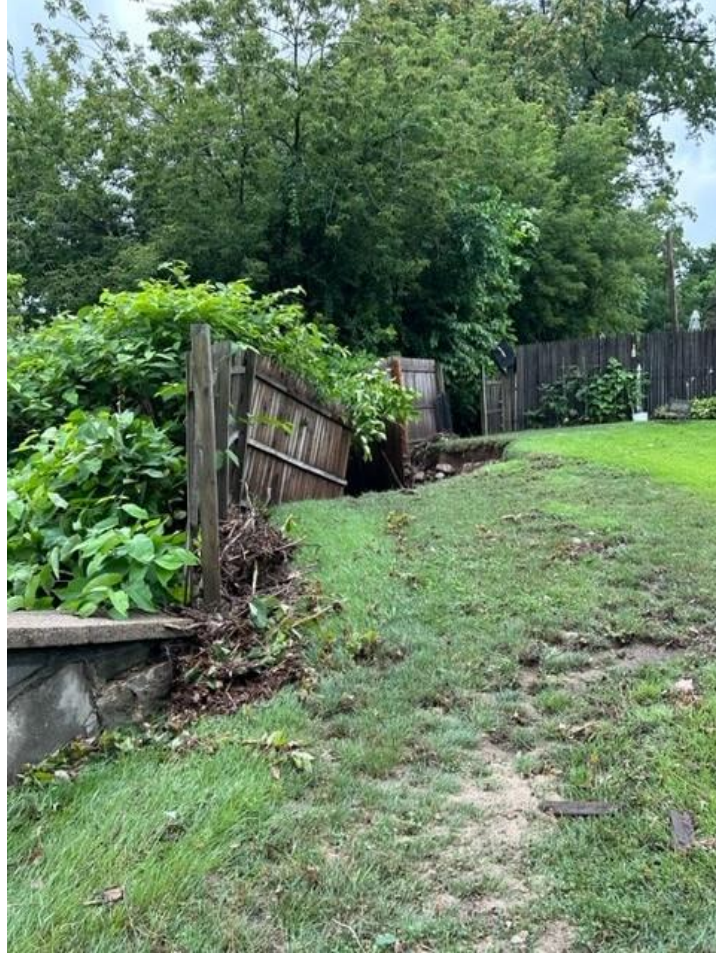
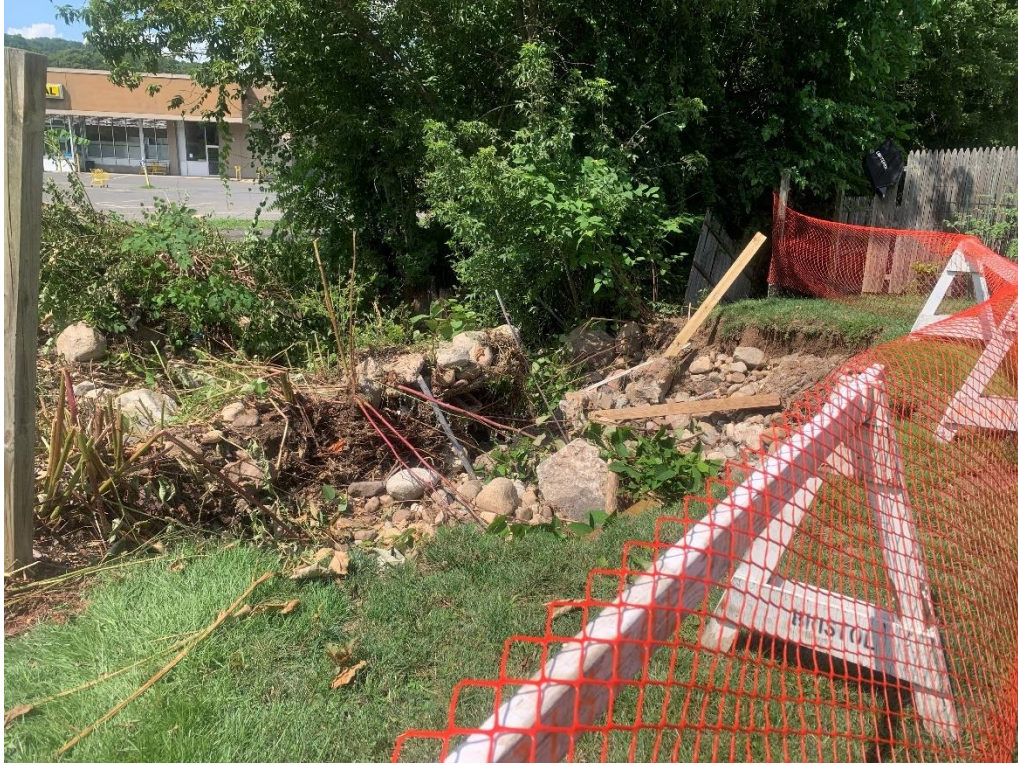
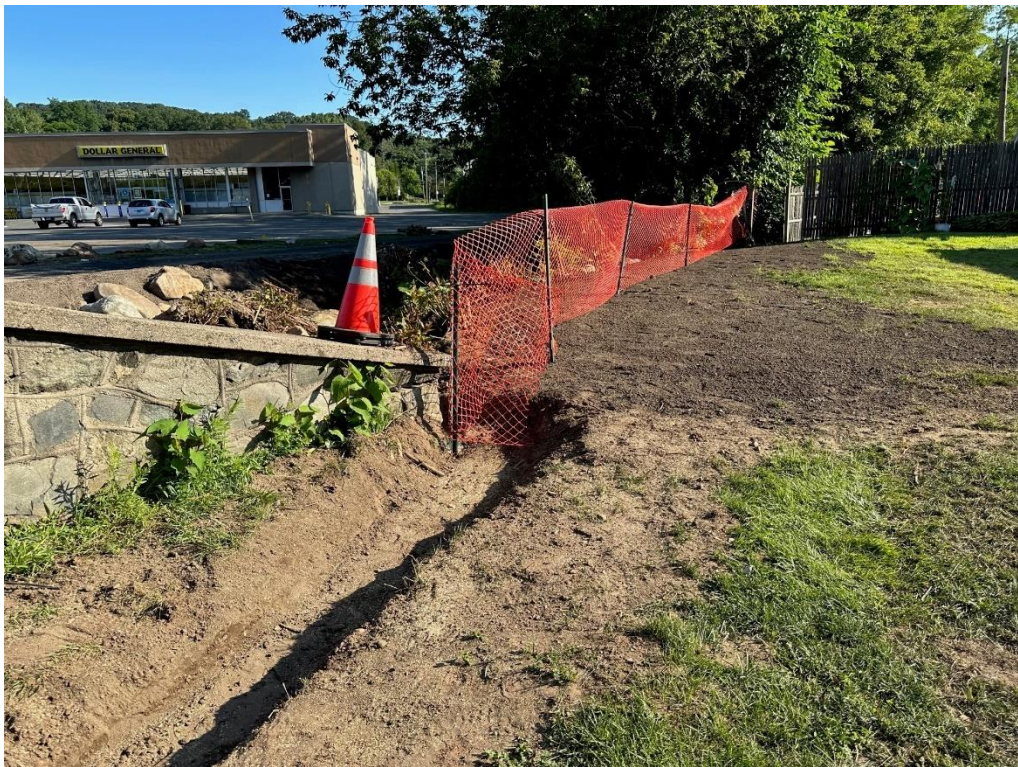
An unnamed stream flowing south to north crosses Divinity Street 250 ft east of the intersection of Peck Lane. Flows are facilitated by a 5 ft x 5 ft concrete box culvert which is hydraulically undersized. During the storm on July 16<sup>th</sup> floodwaters overtopped the culvert and caused significant damage do the adjacent properties as shown in the photos below.

*Figure 55: 316 Divinity Street Property Damage*

*Figure 56: 316 Divinity Street Property Damage*

*Figure 57: 316 Divinity Street Property Damage*

The DPW sent a crew onsite to temporarily repair the damages to the adjacent properties. The Department is currently in the process of finalizing the design of a new culvert. The culvert size will increase from 5 ft high X 5 ft wide to 5 ft high by 8 ft wide. Work is scheduled to be completed after the completion of the CT DOT Route72/69 project. Culvert is currently on the West End intersection detour plan (2024).

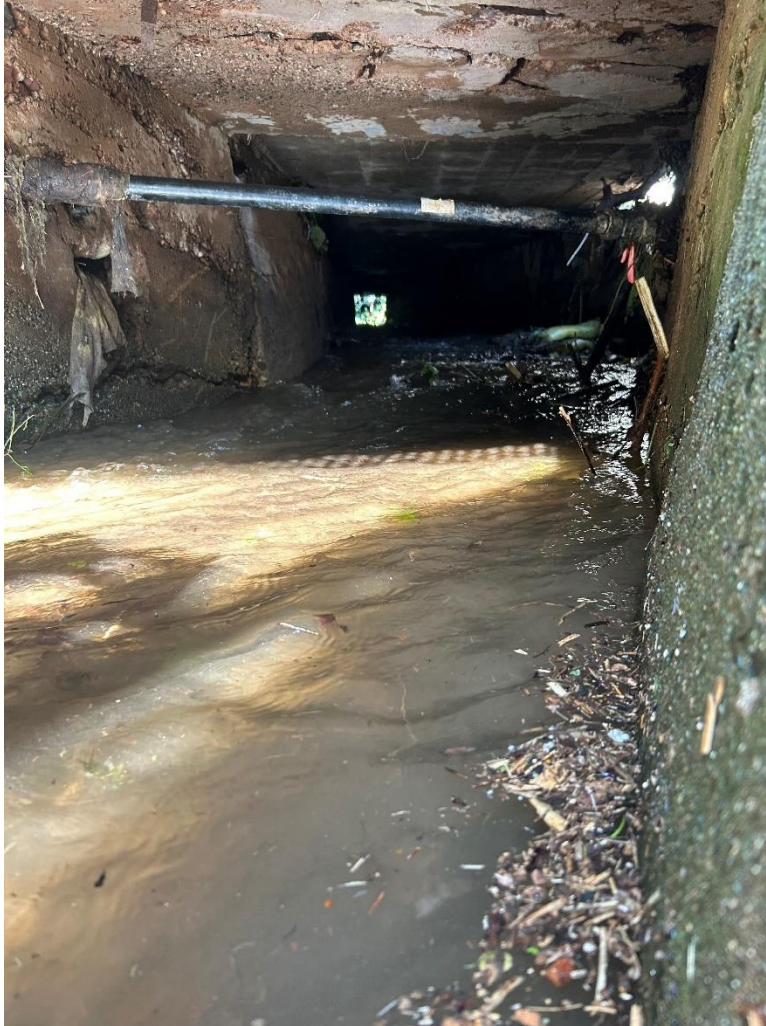
An unnamed stream flowing west to east parallel to Park Street caused severe flooding when water overtopped the roadway during the storm on July 16<sup>th</sup>. A large contributor to the flooding was a private culvert clogged with 30'-40' of debris. The buildup of debris was partially caused by an exposed gas lateral penetrating through the culvert. Due to the blockage flows were forced out of the channel and over the roadway. Another large contributor to the flooding was a dumpster upstream that was washed into the watercourse and became lodge against a pedestrian bridge impeding flow. The flooding extended from the culvert along Park Street to the intersection of RT 69.

*Figure 60: Private Culvert Cleared of Debris*

The culvert has been cleared by a private contractor as directed by the DPW. DPW has approached Eversource regarding relocation of the lateral as to help prevent the buildup of debris in the future.

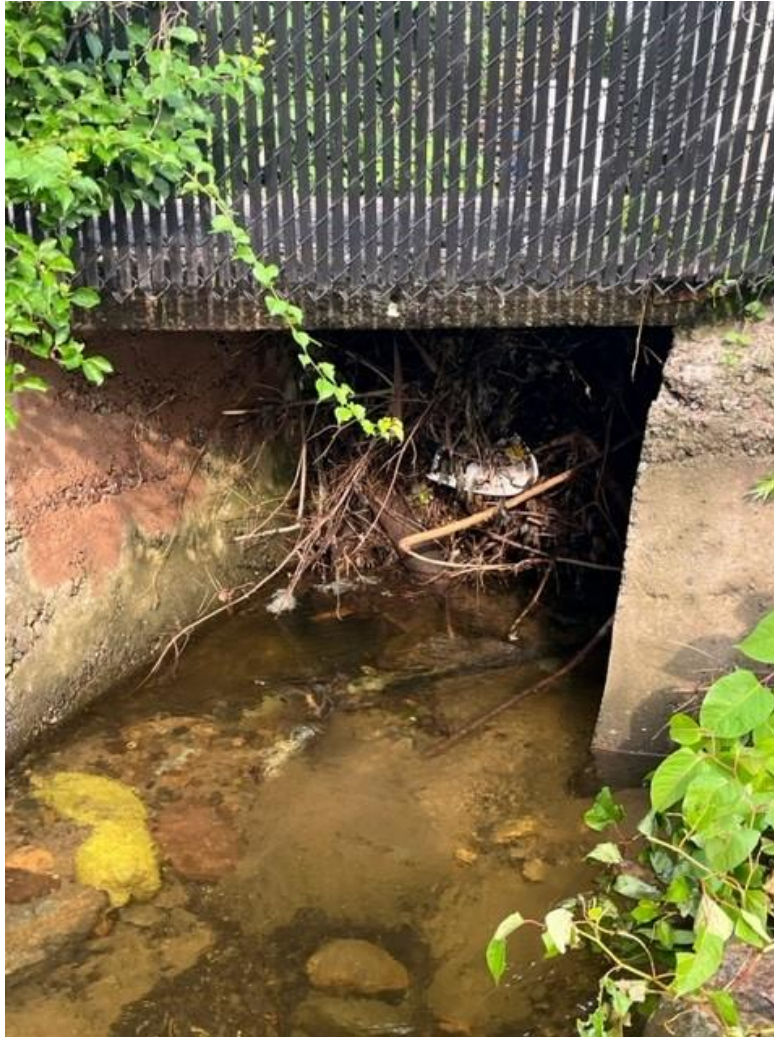
*Figure 61: Buildup of Debris Within Private Culvert*

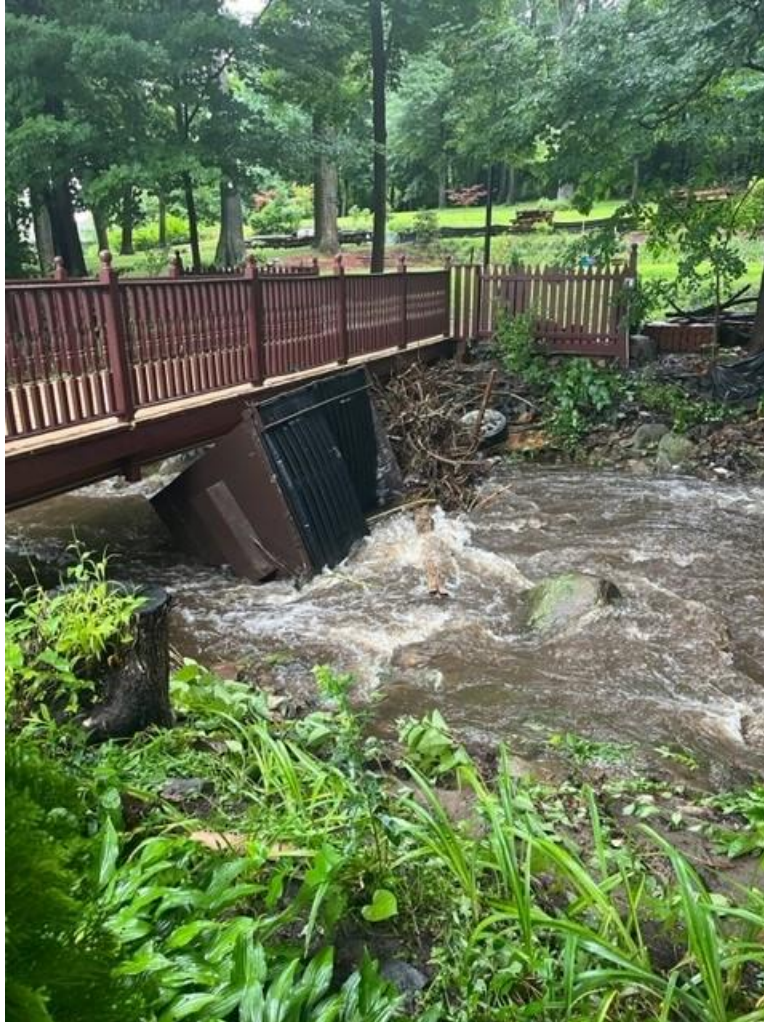
*Figure 62: Dumpster Obstructing Flows*

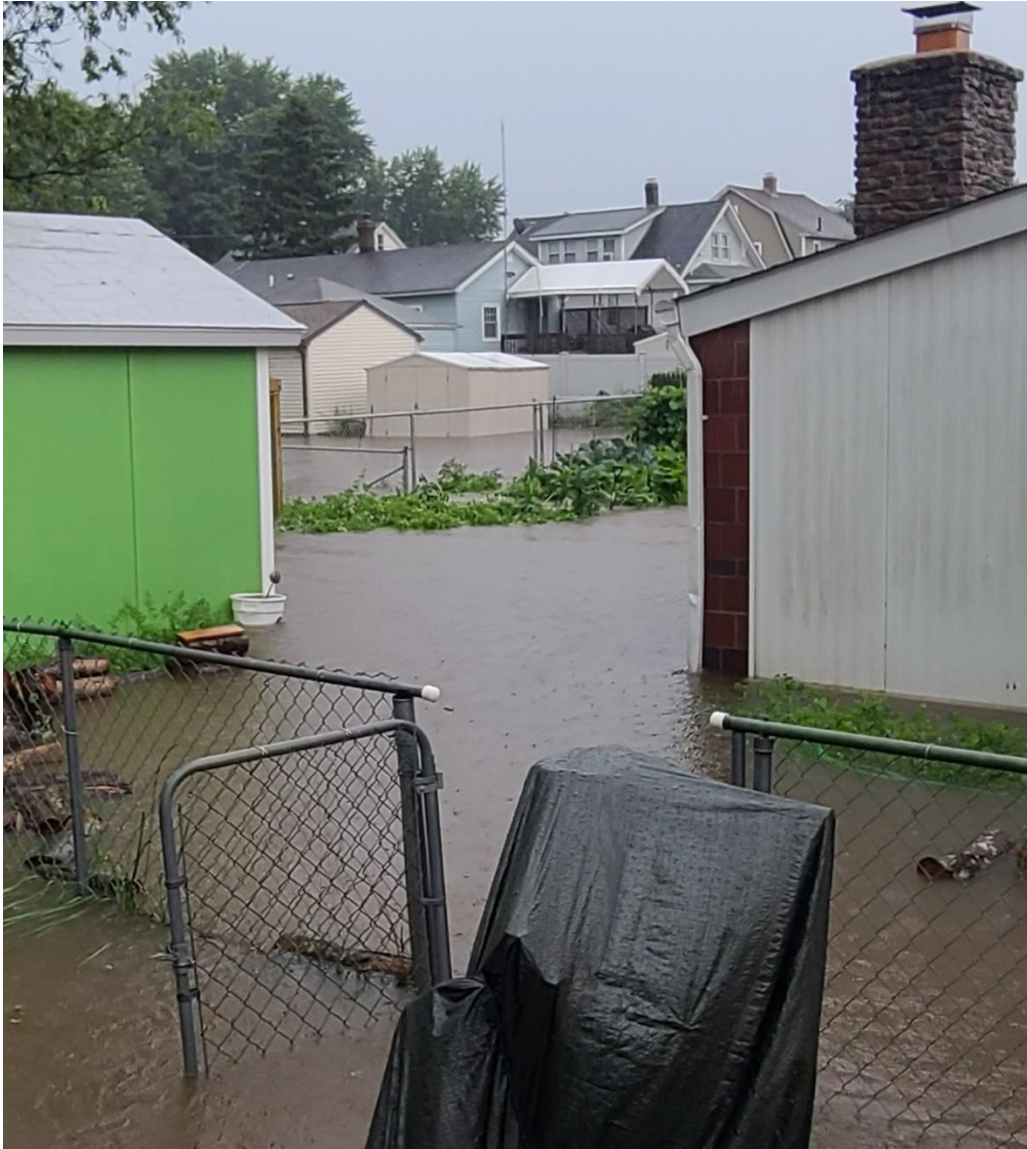
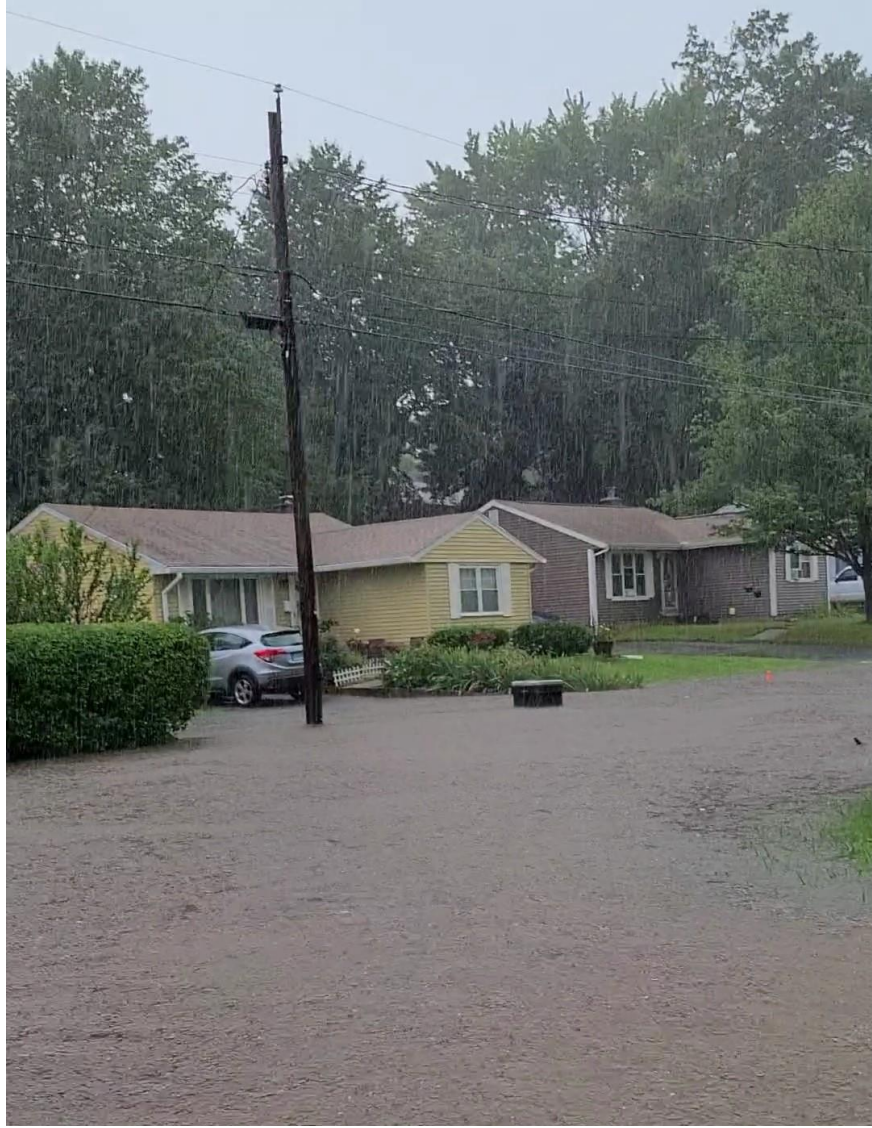
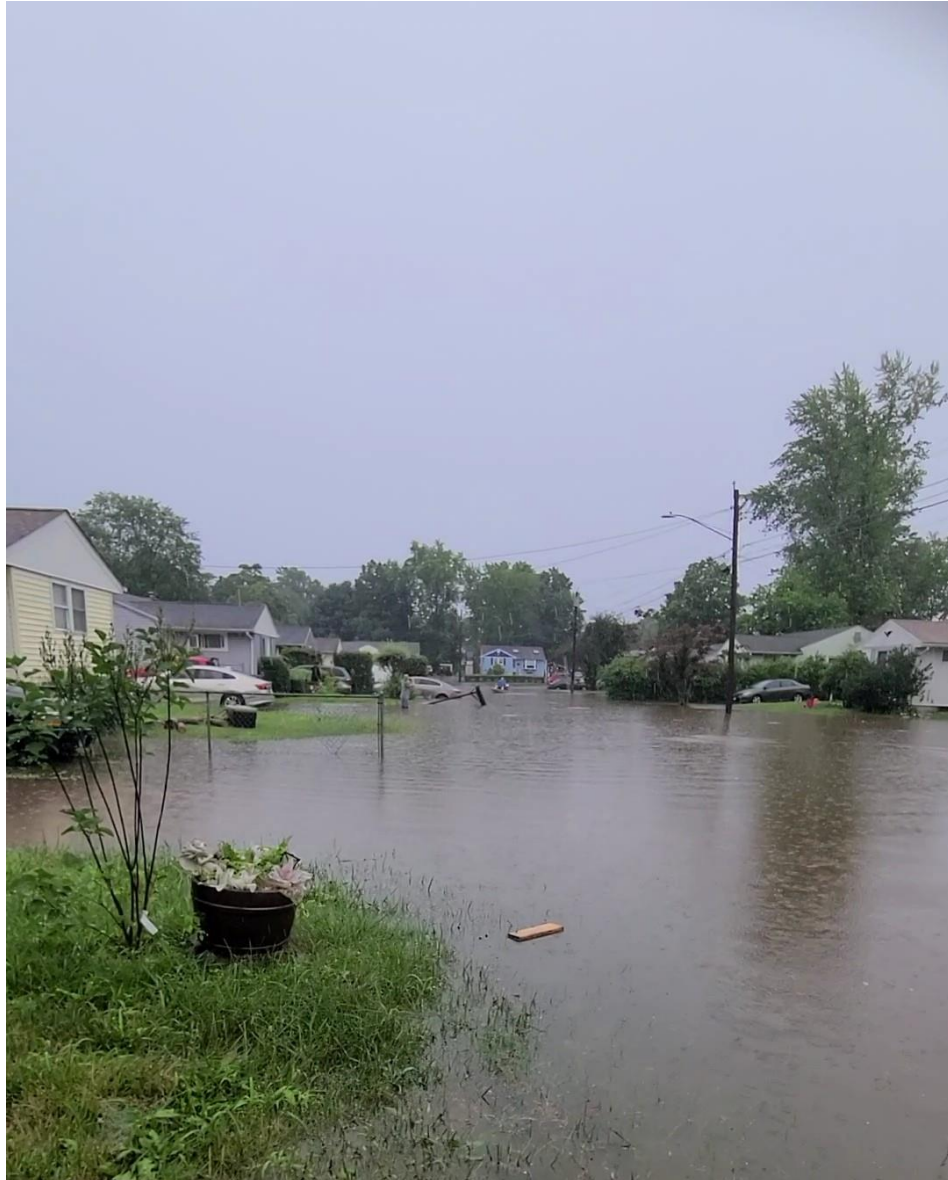
*Figure 68: Sharon Street Flooding*

*Figure 69: Sharon Street Flooding*

*Figure 70: Sharon Street Flooding*

DPW jetted/cleaned the drainage piping to ensure that it clear and is scheduled to perform a video inspection of the pipe connecting into the Burlington Ave (CT Route 69) drainage system to ensure that there are no blockages. We are also modifying the down gradient manhole grate to increase flow. DPW will be contacting the State regarding increasing the capacity of the Burlington Ave (CT Route 69) drainage system.

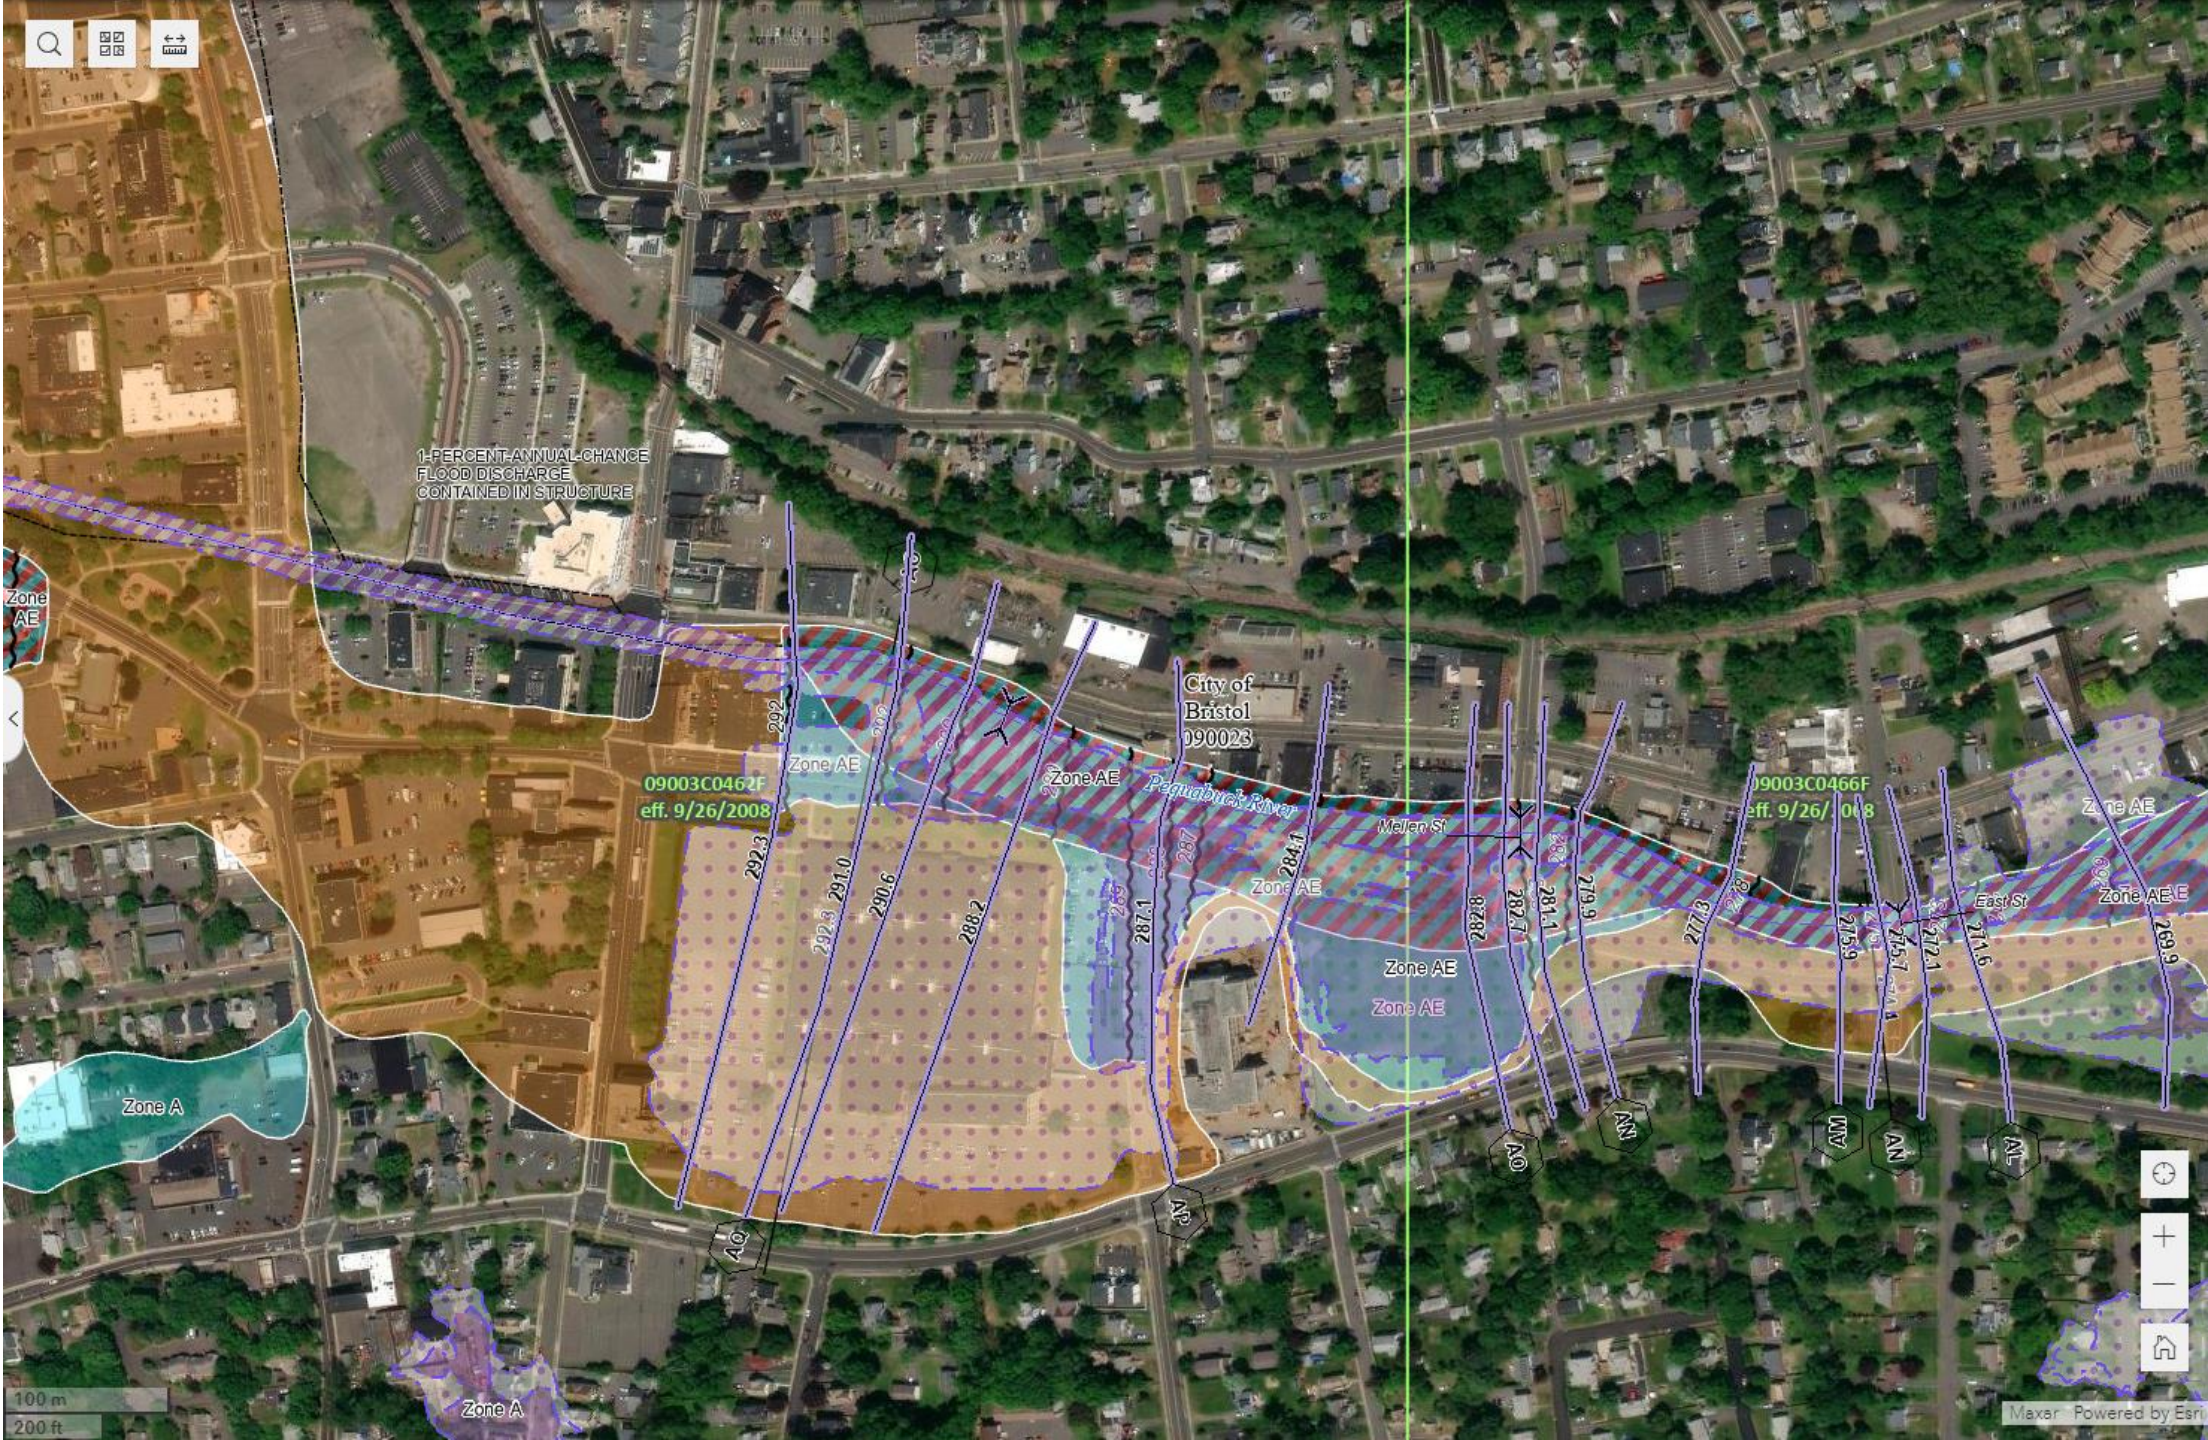
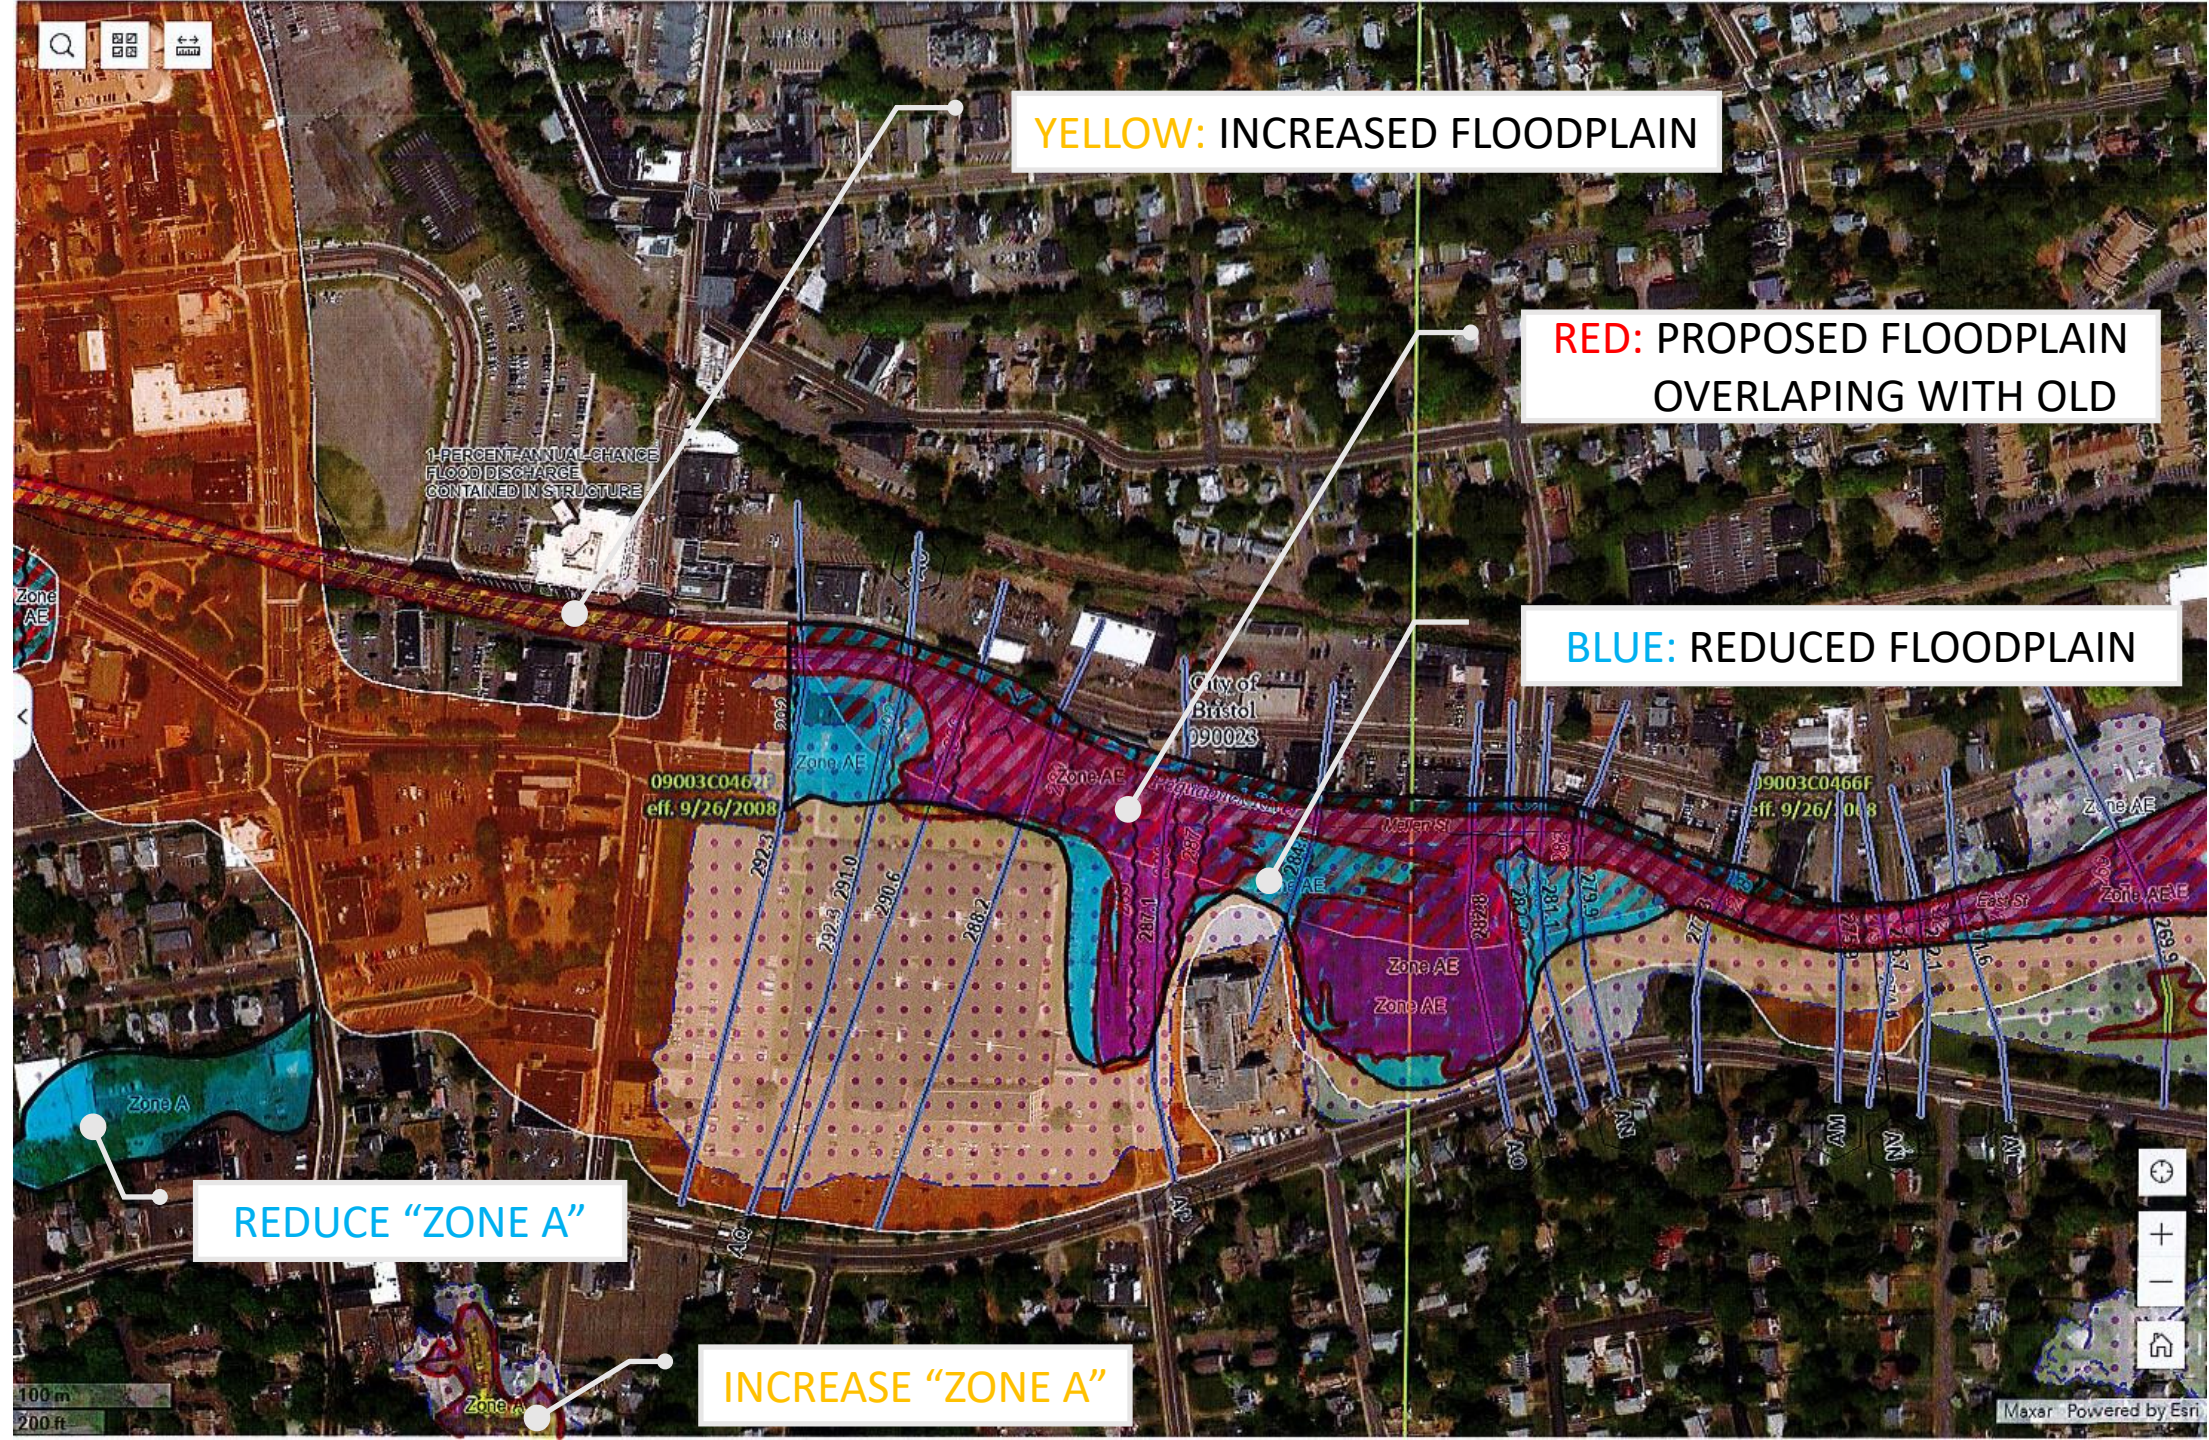
YELLOW: INCREASED FLOODPLAIN

RED: PROPOSED FLOODPLAIN  
OVERLAPING WITH OLD

BLUE: REDUCED FLOODPLAIN
