# Site/Building Analysis

## for a proposed Animal Control Facility

**Date of field Visit:** September 3, 2024  
**Attn:** Roger Rousseau  
**Company:** City of Bristol, CT  
**Company Address:** 111 North Main Street, Bristol, CT 06010  
**Assessment Address:** 30 Cross Street, Bristol, CT

# MEP PROPERTY CONDITION REPORT

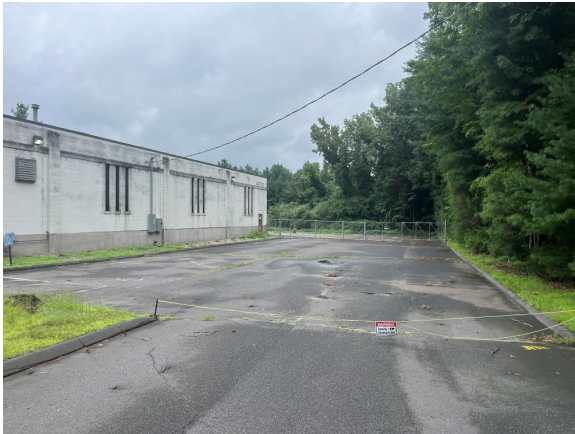
Reference Image – 1.1

| Item # | Assessment Element | Recommendation for future renovation | Ref. Image |
|---|---|---|---|
| 1.1 | The existing Driveway/Parking Consists of cracked asphalt, no visible storm drainage, and a large ramp for a loading dock at the rear of the building. | Provide new asphalt paving and new configuration to allow for outdoor animal runs, new storm drainage, and sufficient parking. Infill existing loading dock to accommodate van access into the building. | <input checked="" type="checkbox"/> |

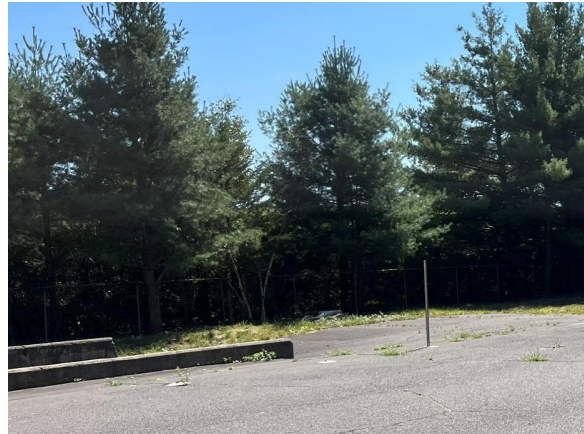
Reference Image – 1.2

| Item # | Assessment Element | Recommendation for future renovation | Ref. Image |
|---|---|---|---|
| 1.2 | The existing site fencing is dilapidated; Rusted, bent, and/or overgrown with vegetation. | Replace with new aluminum chain link fencing to maintain site security. Provide additional fencing for new animal exercise yards. | <input checked="" type="checkbox"/> |

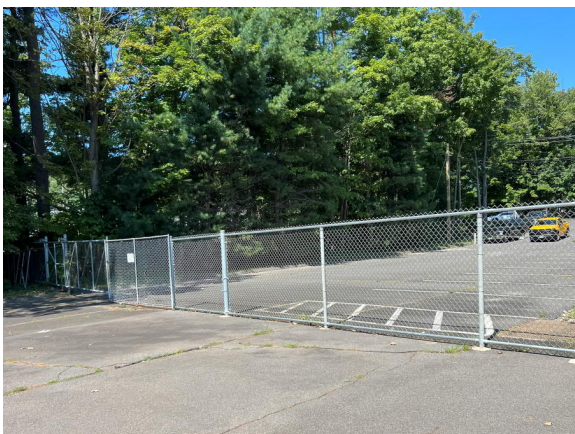
Reference Image – 1.3

| Item # | Assessment Element | Recommendation for future renovation | Ref. Image |
|---|---|---|---|
| 1.3 | The existing access control gate dividing the front and rear parking lot appears in good condition, however it is becoming overgrown with vegetation. | Cut back vegetation and modify fencing as needed to accommodate new asphalt paving.<br><br>This fence may need to be relocated depending on the final proposed site layout. | <input checked="" type="checkbox"/> |

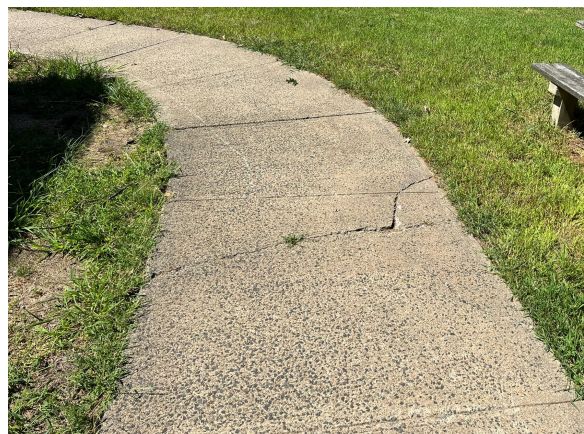
Reference Image – 1.4

| Item # | Assessment Element | Recommendation for future renovation | Ref. Image |
|---|---|---|---|
| 1.4 | The existing main entrance sidewalk appears in fair condition, however there are a few cracks. This sidewalk could remain however feature wear and tear could result in heaving of individual concrete panels. | Replace sidewalk in its entirety to avoid future safety concerns and accommodate renovations for new animal control facility. | <input checked="" type="checkbox"/> |

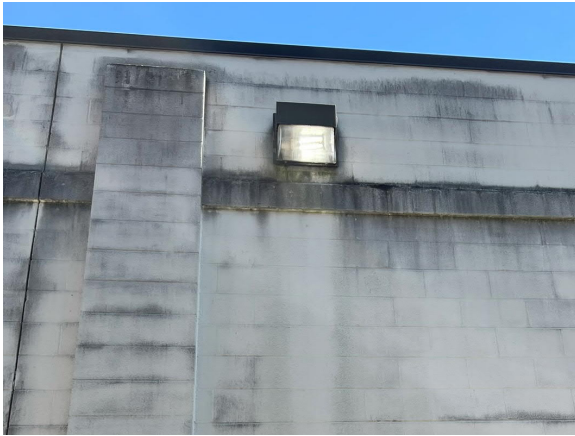
Reference Image – 1.5

| Item # | Assessment Element | Recommendation for future renovation | Ref. Image |
|---|---|---|---|
| 1.5 | There are existing site lights mounted to the side of the building which do not appear to be energy efficient. | Provide new building mounted LED site lighting to accommodate renovations for new animal control facility. | <input checked="" type="checkbox"/> |

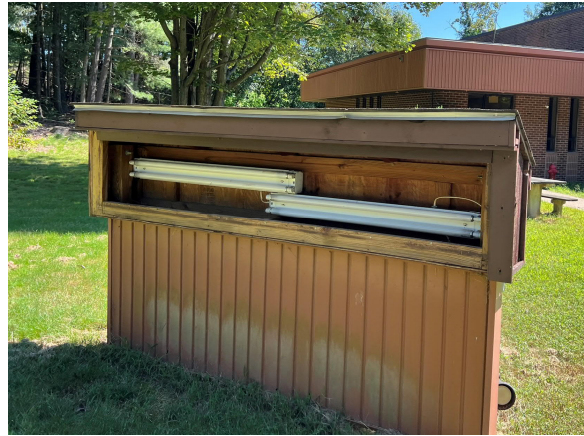
Reference Image – 1.6

| Item # | Assessment Element | Recommendation for future renovation | Ref. Image |
|---|---|---|---|
| 1.6 | The existing tenant monument sign appears dilapidated. | Demo existing signage and provide new monument and/or building mounted signage. | <input checked="" type="checkbox"/> |

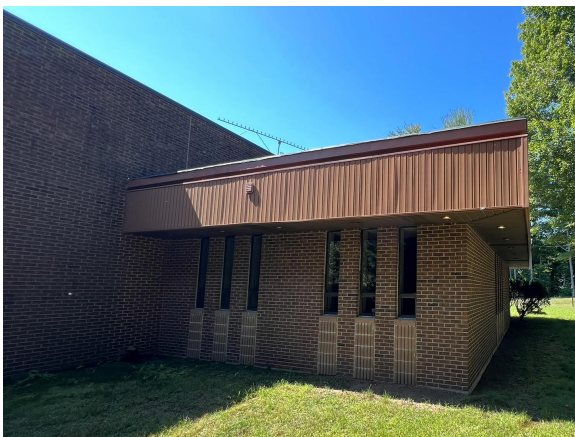
Reference Image – 2.1

| Item # | Assessment Element | Recommendation for future renovation | Ref. Image |
|---|---|---|---|
| 2.1 | The existing brick façade appears in good condition. Mortar is not spalling and weep holes are visible. | No visible recommendations for repair. | ☒ |

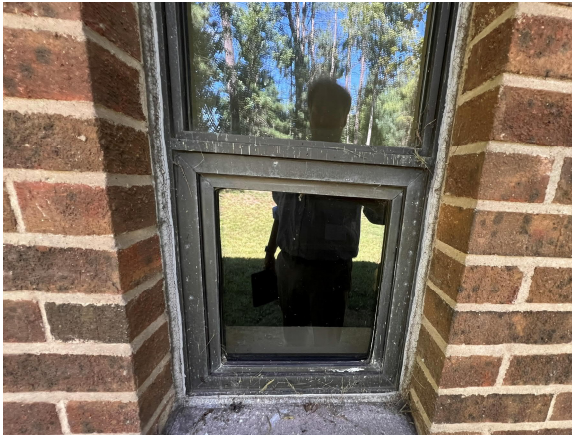
Reference Image – 2.3

| Item # | Assessment Element | Recommendation for future renovation | Ref. Image |
|---|---|---|---|
| 2.3 | The existing aluminum storefront appears in fair condition however it's anticipated that the storefront system is not code compliant for energy efficiencies. | Replace the existing aluminum storefront system with new energy efficient units. Modify masonry openings as necessary to accommodate renovations for new animal control facility. | ☒ |

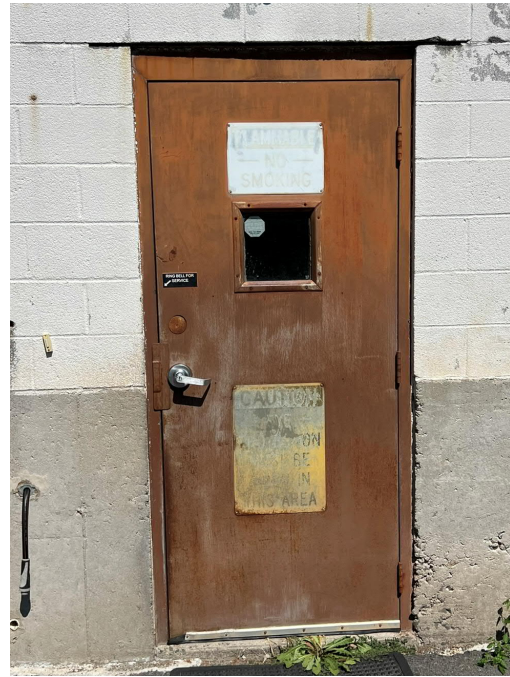
Reference Image – 2.4

| Item # | Assessment Element | Recommendation for future renovation | Ref. Image |
|---|---|---|---|
| 2.4 | All hollow metal doors and frames appear dilapidated. Finishes are rusted and dented. Few doors are missing code compliant hardware for accessibility. | Replace all hollow metal doors, frames and hardware with new cold compliant assemblies. | ☒ |

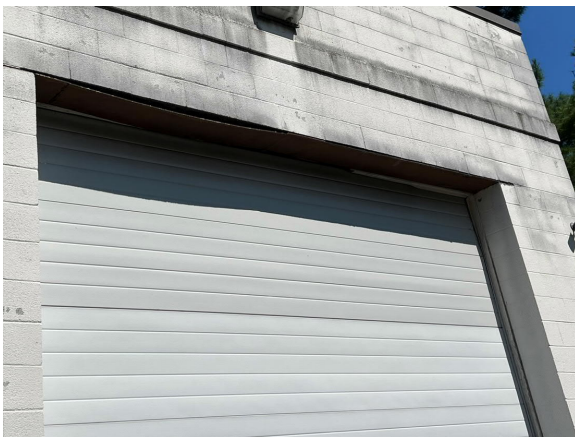
Reference Image – 2.5

| Item # | Assessment Element | Recommendation for future renovation | Ref. Image |
|---|---|---|---|
| 2.5 | There are three existing overhead doors, two access flush with pavement, and the third accesses the loading dock. All doors appear in fair condition; however, the masonry opening steel lents are showing signs of rust and are bending below the CMU wall system. No signs of CMU collapse are evident. | Three overhead doors do not appear to be required for the future program. Plus, all there overhead doors take up significant exterior wall space that could be used for other program functions. Infill overhead doors where opening is not required. Provide new steel lintel and new insulated overhead door unit at any existing overhead door location to remain. | ☒ |

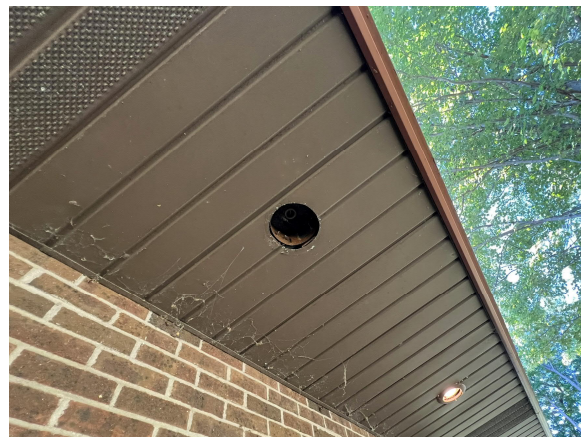
Reference Image – 2.6

| Item # | Assessment Element | Recommendation for future renovation | Ref. Image |
|---|---|---|---|
| 2.6 | The existing aluminum fascia at the exterior soffit around the office wing appears in fair condition however there are a few missing soffit lights. | Remove all existing lighting and provide new energy efficient LED lighting. | ☒ |

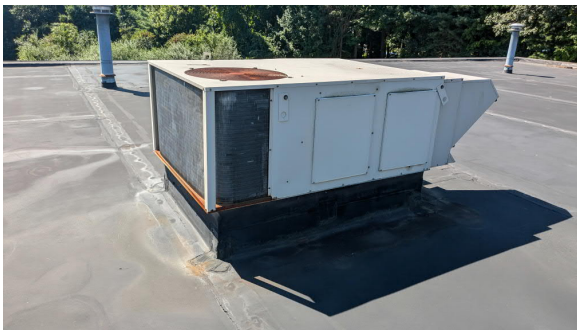
Reference Image – 2.7

| Item # | Assessment Element | Recommendation for future renovation | Ref. Image |
|---|---|---|---|
| 2.7 | The existing roofing appears in fair condition. There was no visible ponding during the time of inspection however there is minor | It is unclear to tell if the roof leaks are active or from a prior roof system. If the roof leak or from a prior roof installation, then roof replacement | ☒ |

| Item # | Assessment Element | Recommendation for future renovation | Ref. Image |
|---|---|---|---|
| | dilapidation at the seams. Also, the crickets between the roof drains do not appear to have adequate pitch for quick drainage. Evidence of prior ponding between drainage is evident. Additionally, there is evidence at the inside face of exterior walls, between roof drains, of prior leaks. | isn't recommended, however, repair of seams and modification of crickets could be helpful to extend the life of the roofing system. | |

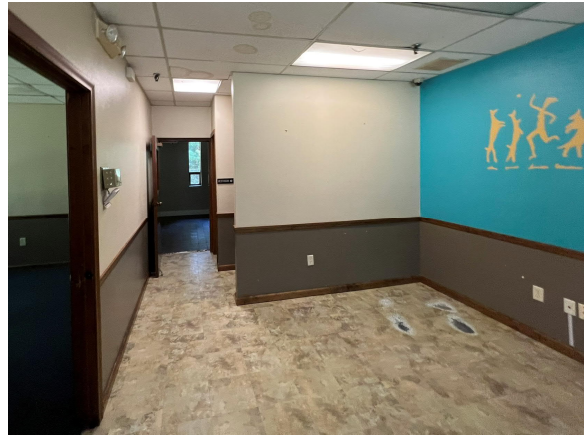
Reference Image – 3.1

| Item # | Assessment Element | Recommendation for future renovation | Ref. Image |
|---|---|---|---|
| 3.1 | The existing front offices appear to be in poor condition. Ceilings are stained, flooring is worn, wall finishes are damaged, and lighting is not energy efficient. Additionally, the existing room layout is likely not amenable for the proposed needs of a future Animal Control Facility. | Demolish existing non load bearing walls, lighting, and finishes to clear way for new Animal Control Facility spatial program. Provide all new and durable finishes, LED lighting, new doors and hardware. | <input checked="" type="checkbox"/> |

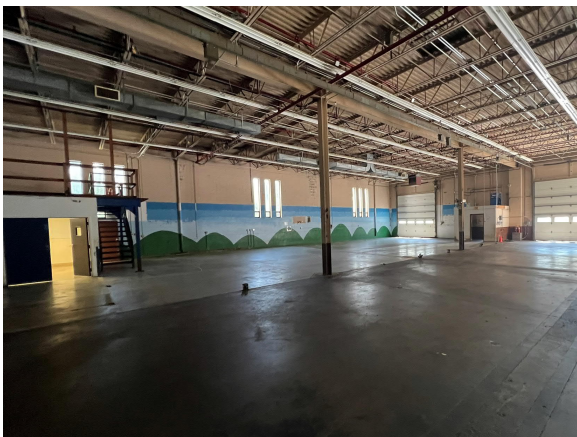
Reference Image – 3.2

| Item # | Assessment Element | Recommendation for future renovation | Ref. Image |
|---|---|---|---|
| 3.2 | The existing open warehouse main level is in good condition. It's likely that the three existing overhead doors are not practical for the proposed future use. | The proposed layout will likely require eliminating and creating various openings within the building envelop for doors, window, kennels, etc. and therefore the exterior, load bearing masonry wall, will require modifications. | <input checked="" type="checkbox"/> |

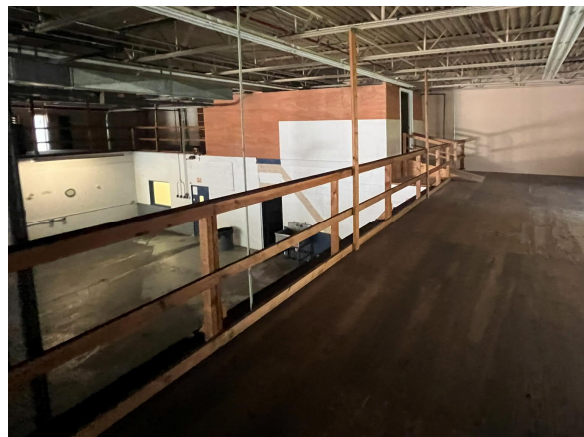
Reference Image – 3.3

| Item # | Assessment Element | Recommendation for future renovation | Ref. Image<br>(Inc. below to match item #) |
|---|---|---|---|
| | <p>existing mezzanine is desired to remain.</p> <p>The mezzanine also does not have an elevator, which will limit the mezzanine functions to those already offered at the main level.</p> <p>The existing "mock" living suit within the mezzanine is not code compliant for accessibility.</p> <p>Floor transitions between various levels of the mezzanine are uneven.</p> <p>The steel mezzanine framing is rusted at few locations.</p> | <p>Demolish all room functions within the mezzanine space that are not offered at the accessible main level.</p> <p>Modify floor transitions to create safe and code complaint transitions between various floor elevations.</p> <p>Scrape, sand, prime, and paint all rusting structural steel to prevent future rust.</p> | |

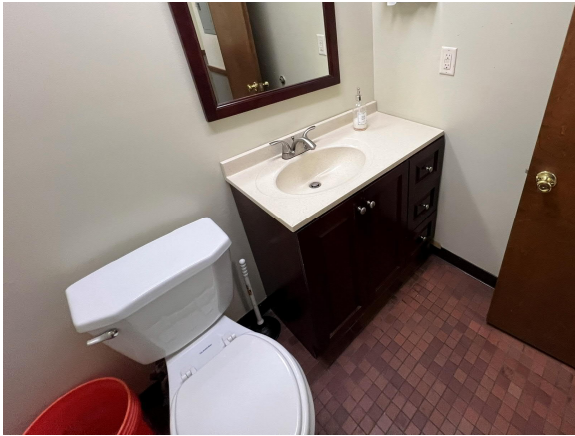
Reference Image – 3.4

| Item # | Assessment Element | Recommendation for future renovation | Ref. Image<br>(Inc. below to match item #) |
|---|---|---|---|
| 3.4 | There are two unisex restrooms within the office area; one accessible and one non-accessible restroom, both which appear in fair condition. | Depending on the proposed layout, these restrooms may need to be relocated, and/or additional restrooms may be required to accommodate the final calculated occupancy. | <input checked="" type="checkbox"/> |

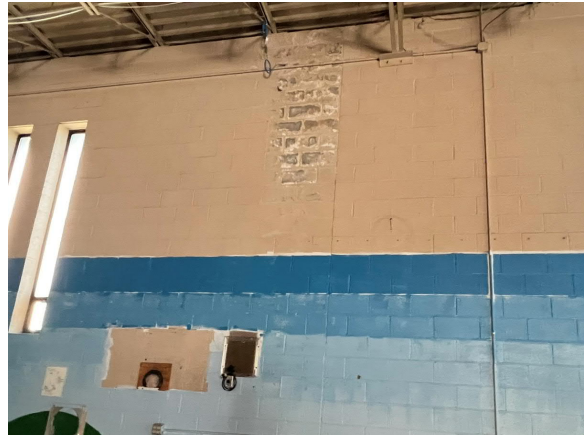
Reference Image – 3.5

| Item # | Assessment Element | Recommendation for future renovation | Ref. Image<br>(Inc. below to match item #) |
|---|---|---|---|
| 3.5 | <p>The existing exterior walls appear to be a mass construction of brick and CMU. A wall cavity was not surveyable however it is believed that the wall does not contain insulation. It is also believed that the existing windows are not energy efficient.</p> <p>In addition to the exterior wall construction, there does appear to be prior water leaks at the top of CMU walls within the warehouse. No current moisture is visible therefore it is assumed the visibility of prior leaks has occurred from a previous roof system.</p> | <p>It is anticipated that the proposed building renovations will be a change of use for the building and therefore energy efficiency will be a required code compliance upgrade. This improvement may be achieved by providing furring and insulation to the interior of the exterior walls.</p> <p>A COM Check shall be created for the proposed renovation which may also trigger other improvements to the windows, lighting, and HVAC, systems.</p> <p>Provide further inspection of the roof construction to ensure no further leaking is eminent.</p> | <input checked="" type="checkbox"/> |

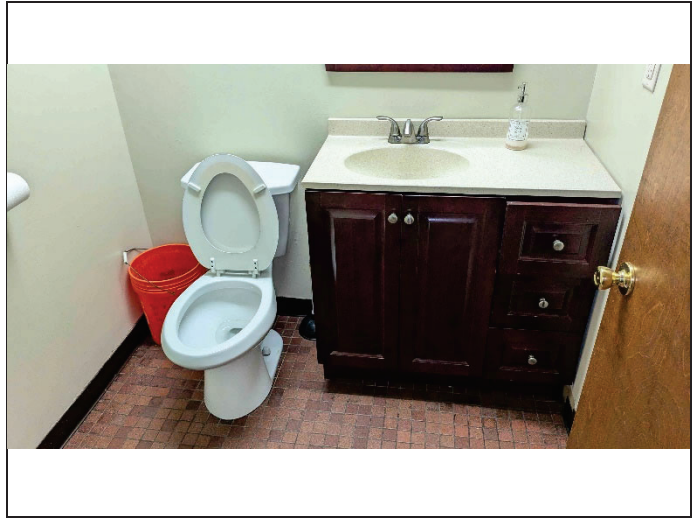
2. Office space plumbing fixtures

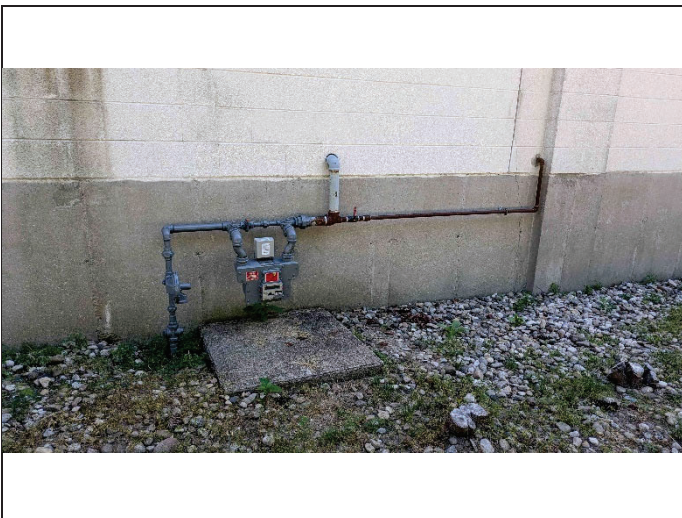
The natural gas system was observed to be in fair overall condition. The natural gas service appears to be adequate for the proposed use of the building as an animal control facility. Exposed natural gas piping located on the roof was observed to be corroded and in poor condition. It is recommended that the exposed natural gas piping be replaced with new and provided with protective paint.

3. Property natural gas utility meter

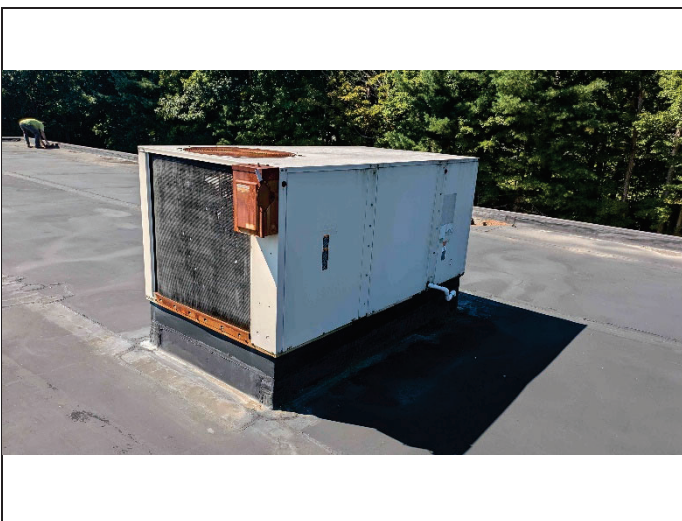
The rooftop packaged units were observed to be in poor overall condition. These types of units have an expected useful life of 20 years and the six units have exceeded their expected service life. Based on the age and observed condition of the units, it is recommended that all rooftop packaged units be demolished. The existing roof curbs can be utilized for mounted the new packaged rooftop units. Existing supply and return ductwork will be utilized where possible based on the proposed renovation of the building.

5. 7.5 Ton packaged rooftop unit serving production area

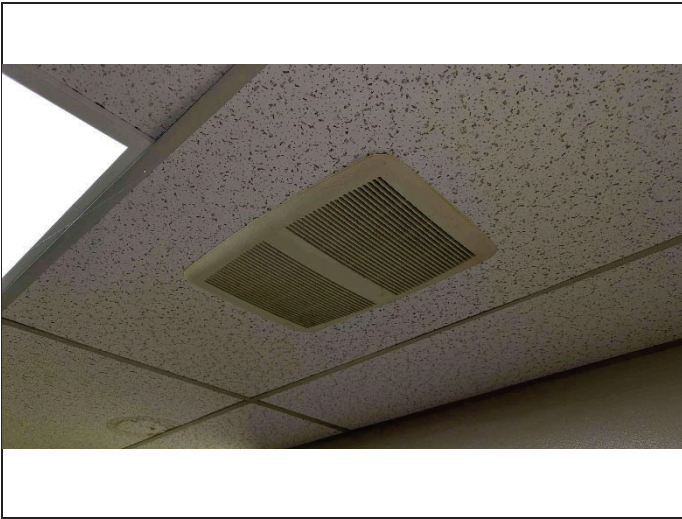
7. Restroom ceiling mounted exhaust fan located in office area

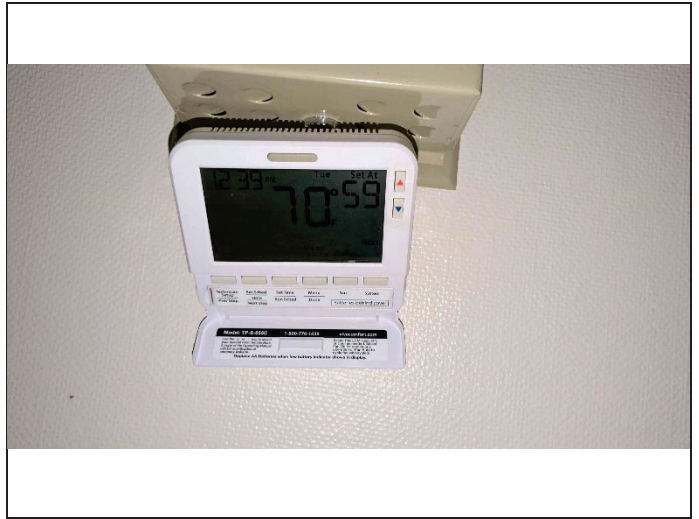
8. Wall mounted thermostat controlling packaged rooftop unit

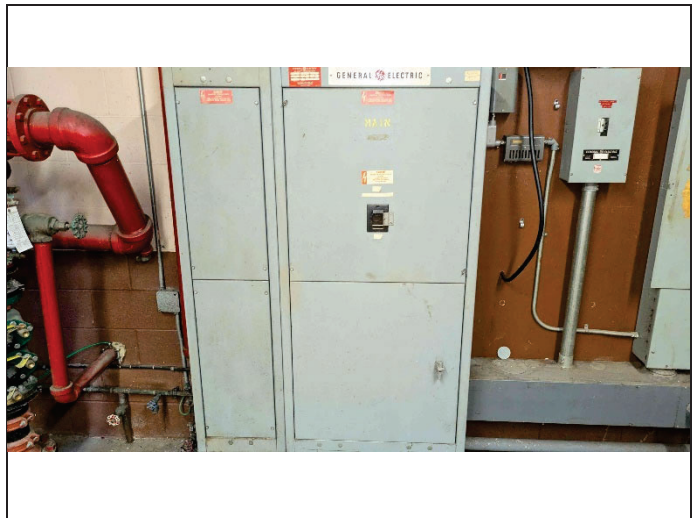
The two electrical services are adequate for the proposed use of the property as an Animal control facility. The existing 800-amp service equipment, step-up transformers, electrical panels, and bus duct are original to the construction of the building. The equipment was observed to be antiquated and in poor condition. It is recommended that this older antiquated electrical service and equipment be removed.

10. 800A, 208-Volt, 3-phase electrical service switch

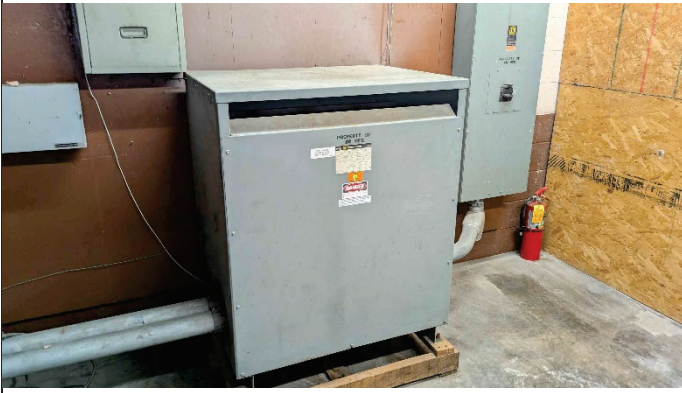
13. 300 KVA Step up transformer serving bus bar in area previously utilized as a production floor

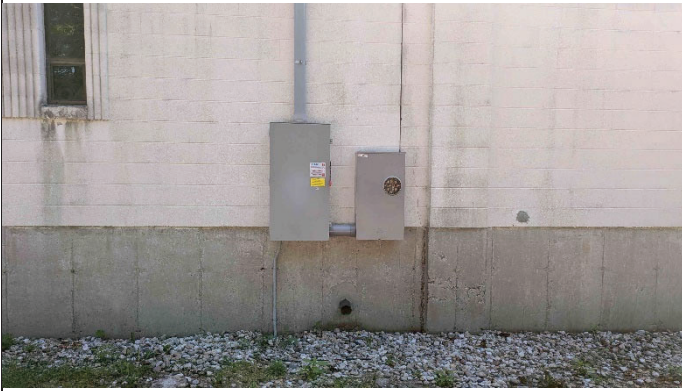
The newer 400-amp, 480-volt electrical service switch and main distribution panel was appears to have been installed in 2017 and was observed to be in good condition. The 400-amp, 480-volt electrical service is capable of providing the building with approximately 31 watts per sq. ft.

15. 400A, 480-V, 3-phase Service disconnect and utility meter

which is more than sufficient capacity for the proposed use of the property as an Animal Control Facility. It is recommended that all electrical power be provided to the building from this newer 400 amp, 480 volt electrical service and that new electrical panels and transformers be installed as a part of the building renovation.
